ACCIDENT 2019/2199

OCCURRENCE NO. – 2019/2199

AIRCRAFT – Aeroplane Yakovlev Yak-52, SP-YDD

DATE AND PLACE OF OCCURRENCE – 15 June 2019, Płock, Vistula River.

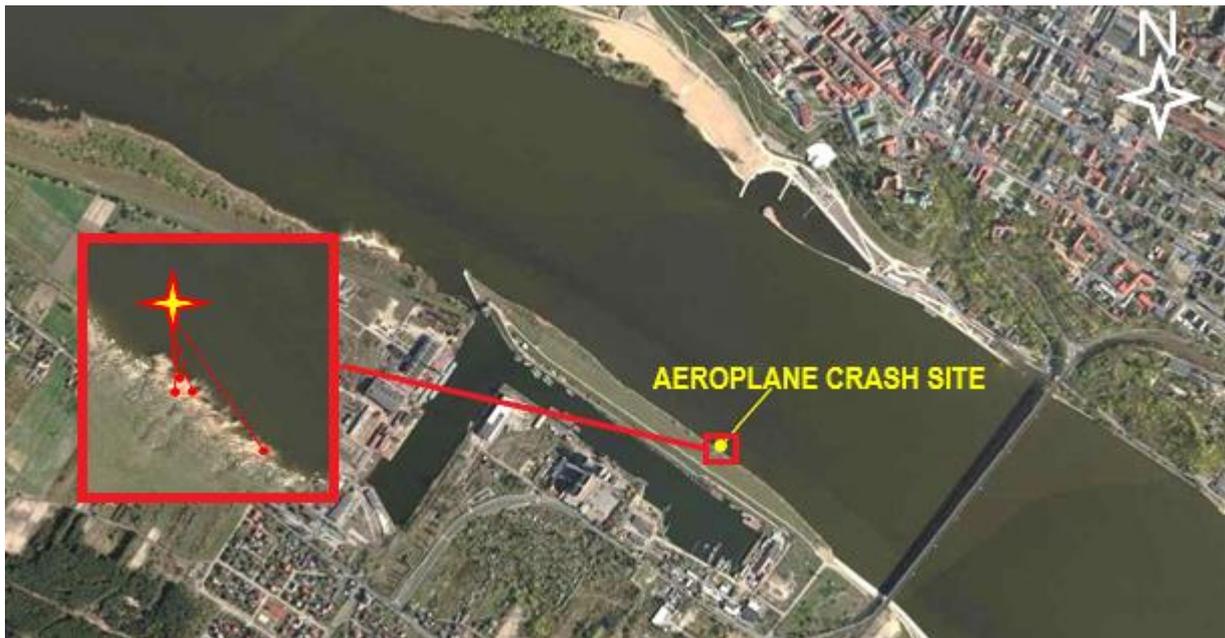
Fig. 2. The aeroplane crash site and approximate dispersion of the wreckage (red frame) [source: PKBWL]

After impact, the aeroplane turned over and rested on the river bottom at a depth of ca. 7 m in the inverted position (cockpit down). On impact, fragments of different sizes detached from the aeroplane and were thrown onto the river bank (Fig. 2).

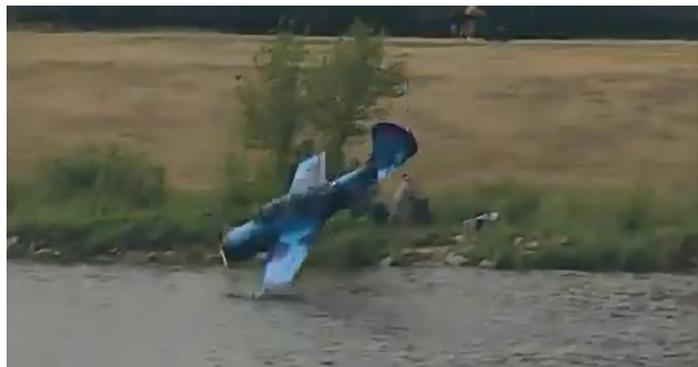
The aeroplane collided with the water surface at an angle of about 25°. The left wing was first to hit water, followed by the engine and right wing (Fig. 3).

Fig. 3. The moment when the aeroplane collided with water [source: Internet]

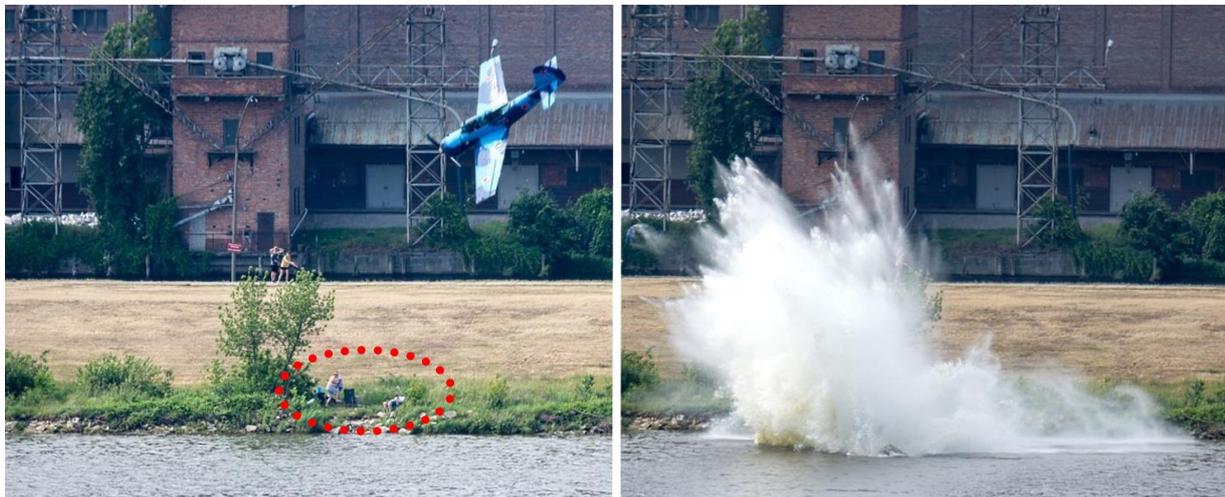
Fig. 4. The fall of the aeroplane [photo: Internet, unknown author]

The course of the accident put at risk a group of several people who were relaxing on the river bank. The aeroplane fell into water at a distance of ca. 12-14 m away from them (Fig. 4). Some wreckage which detached from the aeroplane during the collision with water fell on the river bank.

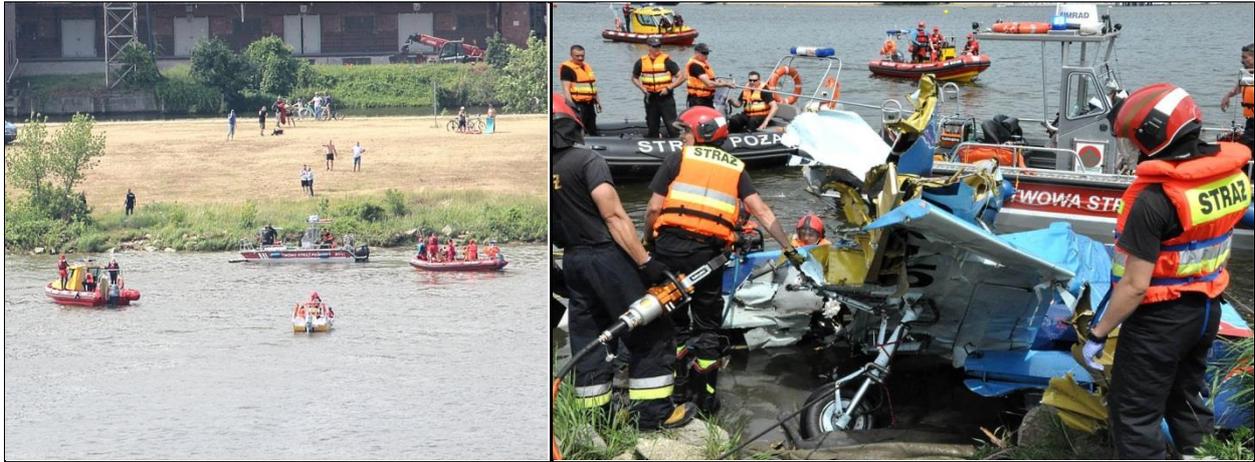
Fig. 5. The rescue operation and recovery of the wreckage [photo: Internet, unknown author and KMP Płock]

After the occurrence, the personnel on water commenced their actions immediately (Fig. 5).

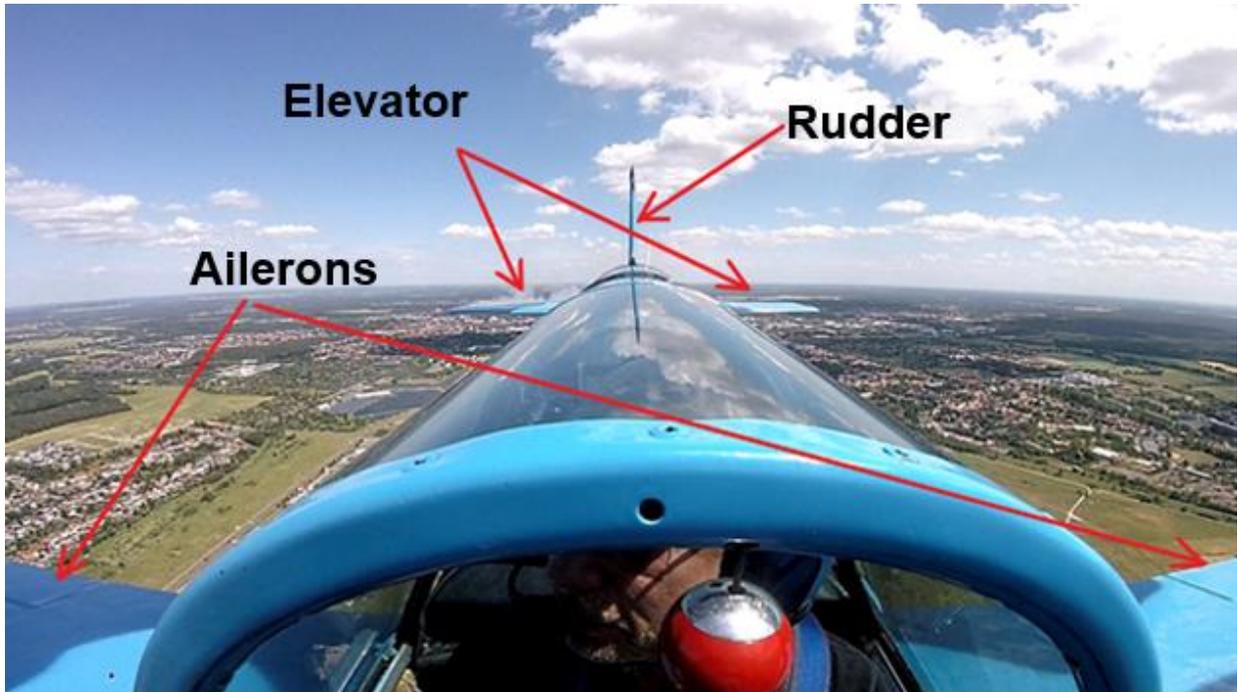
Fig. 6. The image from the camera on the windshield – the aeroplane control surfaces clearly visible  
[source: the owner of the aeroplane – a frame from the video recording]

The analysis of the GoPro video recording allowed the following findings:

- the pilot started the show at ca. 1200 m AGL;
- after entering the zone, he reduced the engine speed, deflected the elevator up and the rudder to the right, entering a spin;

- after a moment, he deflected the control stick to the left;
- on completing 1.5 turns of the spin, the pilot deflected the rudder to the left, the elevator down, and the aileron to neutral;

- on completing another 1.5 turns of the spin, the pilot again deflected the ailerons to the left, and after a moment deflected the elevator up;
- until right autorotation was stopped, the pilot aligned the ailerons to neutral once for two seconds, deflected the elevator down twice for one second, and deflected the rudder several times;

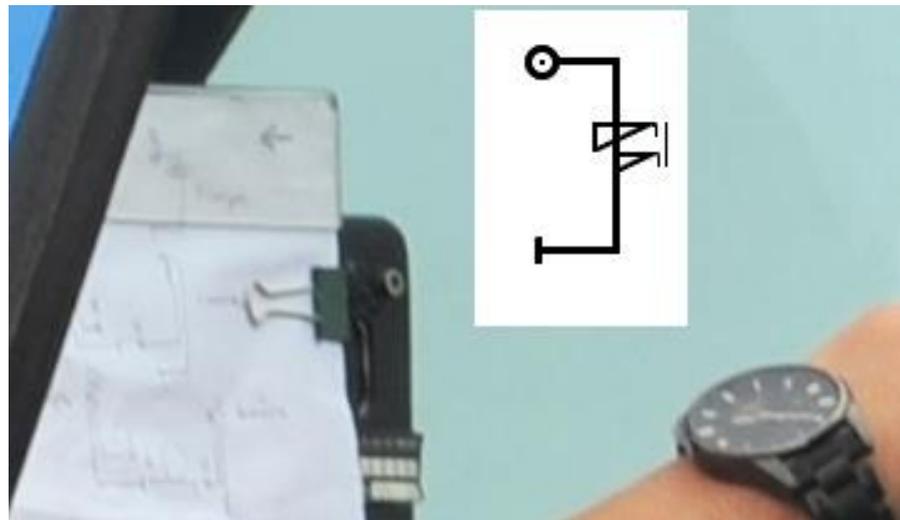
Fig. 7. A photo of a fragment of the sequence affixed in the cockpit on the day of the air show [source:]

Although the close-up image of the sequence is fuzzy, the outline and direction of exiting the figure seem to suggest  $1\frac{1}{2}$  or  $2\frac{1}{2}$  turns of a spin. The video recording of the windshield camera shows the pilot making an unsuccessful attempt to recover from the spin after completing  $1\frac{1}{2}$  turns. The pilot should have set the decision height at which to abandon the aeroplane (by making an emergency parachute jump) in case of an unsuccessful recovery from a spin.

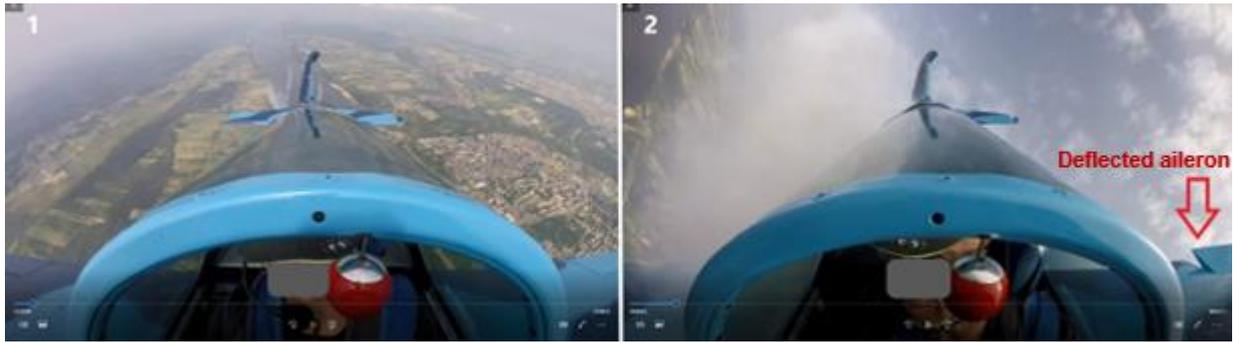
Having entered the air show zone, the pilot deflected the elevator up and the rudder to the right, entering a right spin. After a moment, he deflected the control stick to the left (counter-autorotation-wise) to make the spin flat (Fig. 8).

Fig. 8. Incipient spin [source: the owner of the aeroplane]

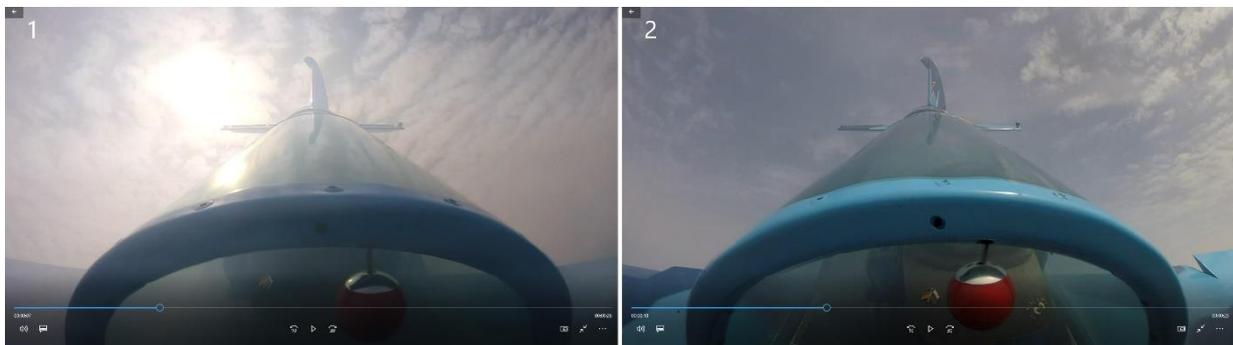
After completing  $1\frac{1}{2}$  turns, the pilot attempted to recover from the spin. He deflected the rudder counter-rotation-wise, deflected the elevator down (the control stick full forward), and set the ailerons in neutral (Fig. 9-1).

Fig. 9. Recovery from the spin [source: the owner of the aeroplane]

After completing  $1\frac{1}{2}$  turns in that configuration, the pilot again deflected the ailerons to the left (Fig. 9-2), making it more difficult to recover the aeroplane from the spin.

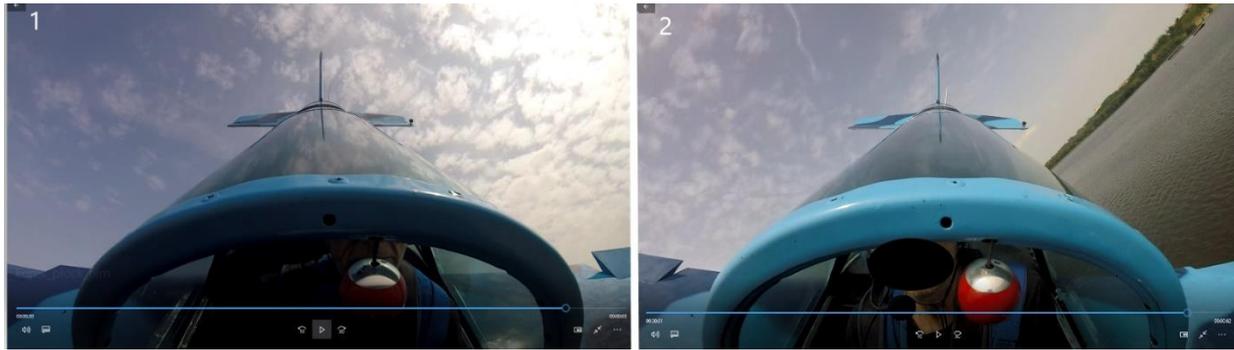
**After  $12\frac{1}{4}$  turns, at a height of ca. 120 m, the aeroplane started entering a left spin** (Fig. 10-1). This is evidenced by the fact that the aeroplane did not accelerate after the autorotation stopped. The elevator was deflected up all the time, the control stick was deflected to the left, and a moment before the collision with the water surface, the pilot moved the control stick to the right to level the aeroplane, but the aeroplane did not respond (Fig. 10-2).

Fig. 10. 1- The moment when the right autorotation stopped. 2- The attempt to level the aeroplane.  
[source: the owner of the aeroplane]
