TRANSPORTATION SAFETY BUREAU

FINAL REPORT

Aero AT-3, HA-BHL

Tököl Airport (LHTL), 18 November 2019

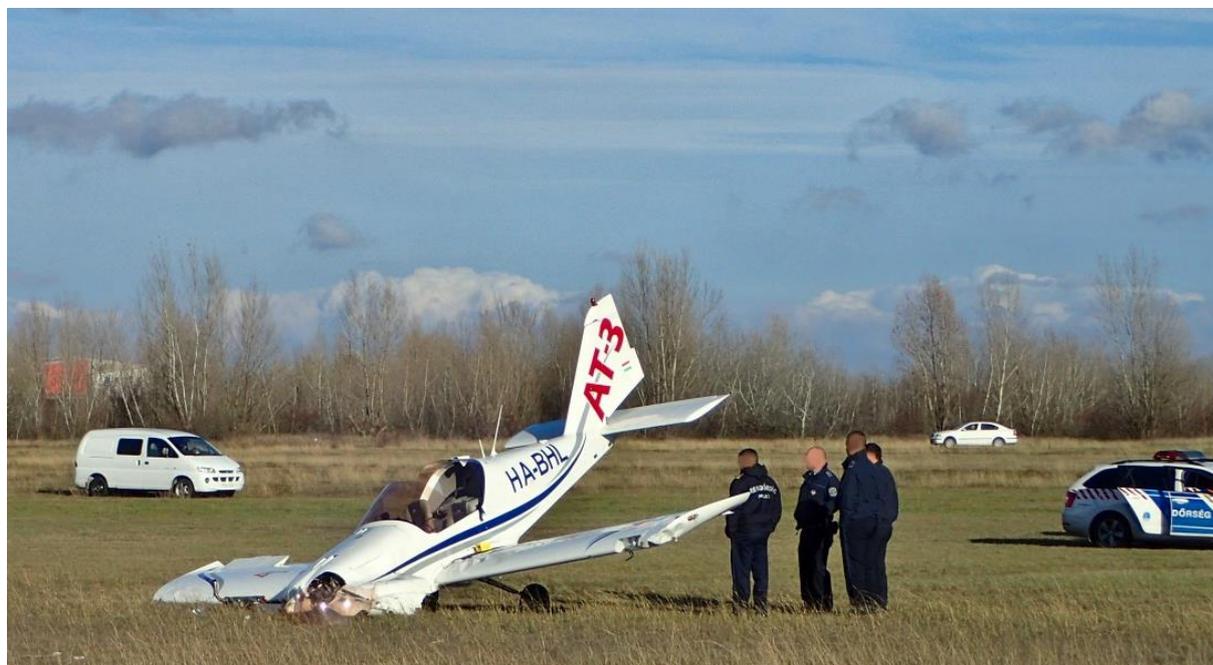
During the trainee's first solo flight with the light aircraft mentioned in the table above, he lost control over the aircraft during take-off phase of the touch and go. According to witness statements, he crashed to the ground from about 2 to 3 metres and came to rest as seen in *Figure 1*.

Figure 1: The damaged aircraft

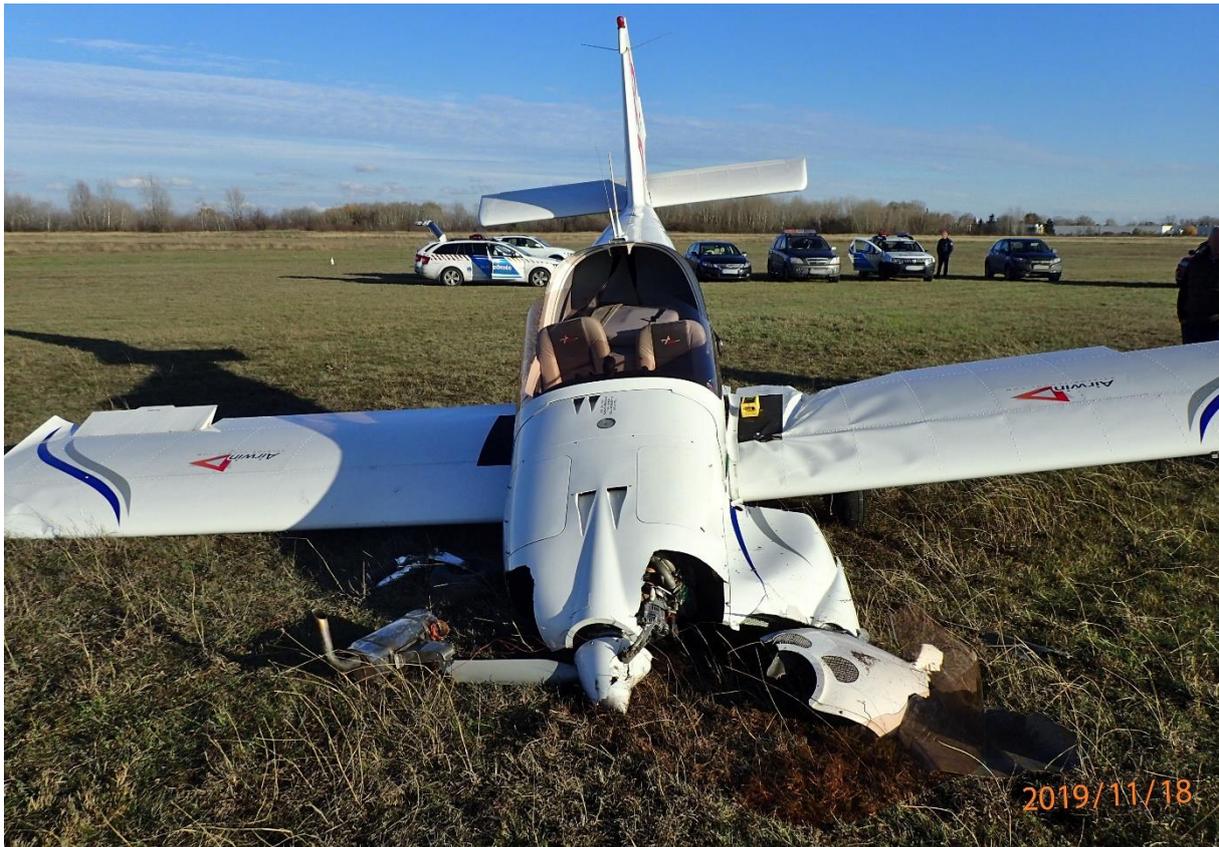
The aircraft was damaged beyond repair as a result of the ground impact. The propeller blades and the nose landing gear broke off, the RH side main landing gear mount was bent out, the wings were severely deformed together with the wing spar root joints; the canopy and the engine cowling fractured.

Figure 2: Visible damages to the aircraft

The investigation did not reveal any information that the aircraft structure had failed prior to the incident, thereby contributing to or influencing the occurrence of the incident.

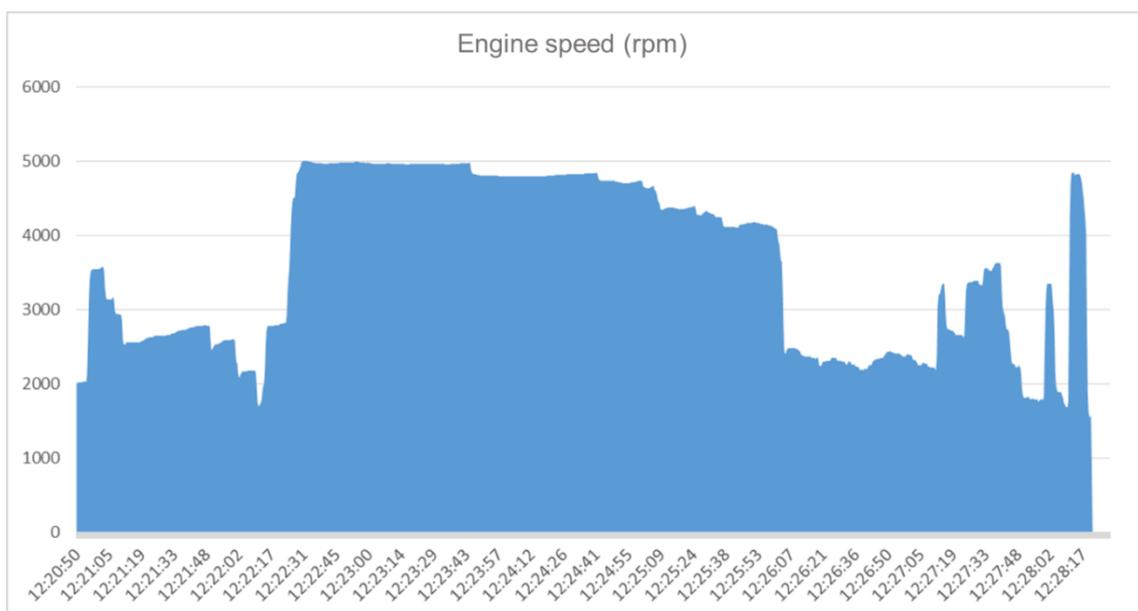
No data recorder is required for the aircraft type affected, but it did have the capability to record engine parameters (engine control instrument, type Electronics International Inc. MVP-50). The speed and altitude values relevant to the investigation were not recorded, but the recorded engine speed data was used by the IC during the investigation. The curve of the engine speeds of the accident flight versus elapsed time is shown below:

Figure 3: Diagram of engine speed as a function of time

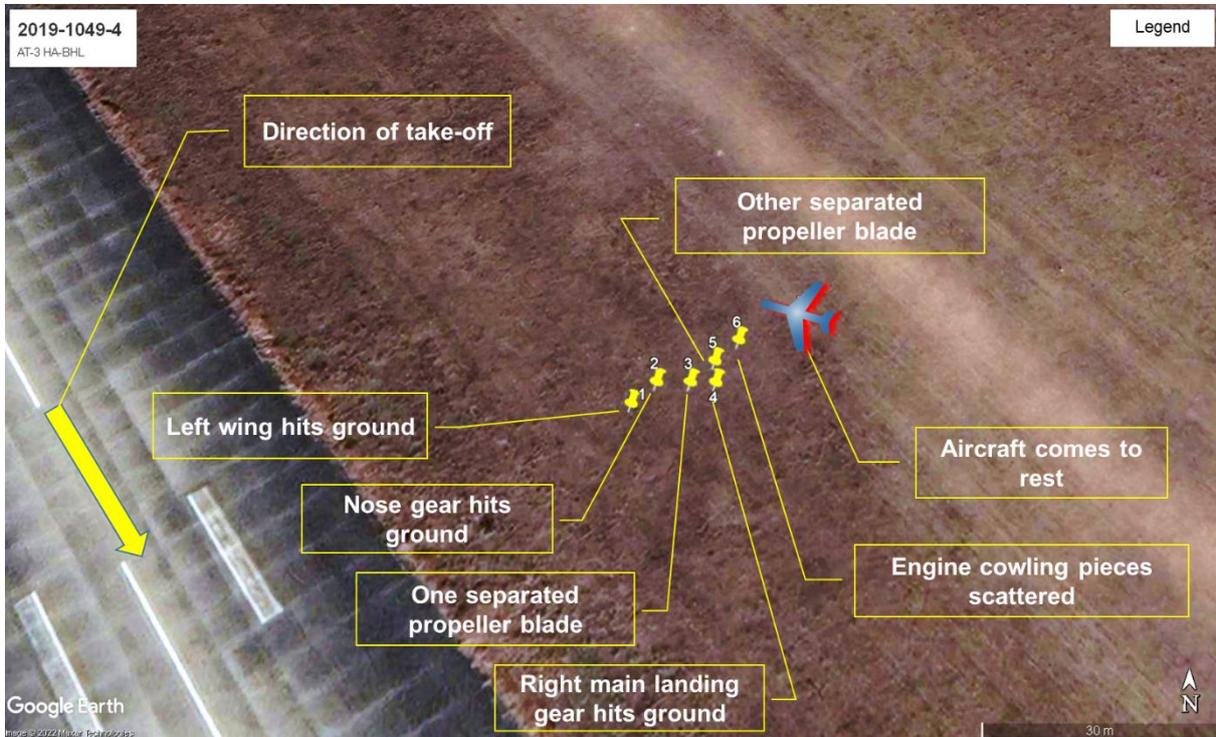
Following an uncontrolled flight after a touch and go, the wreckage of the aircraft was found 100 m to the left of the centre line of the runway 14, more than 180 degrees to the left of the take-off direction, at the coordinates 47°20'33"N, 018°59'09"E. The locations of the marks in the ground are shown in *Figure 4*.

Figure 4: Locations of the marks in the ground

The point of ground impact of the left wing and the position of the propeller blade fracture were identified, as well as the skid marks created by the landing gear. There was no video recording of the accident of sufficient quality, but, based on witness accounts and the traces on the ground, the IC determined the flight path (see *Flight history* chapter for details).

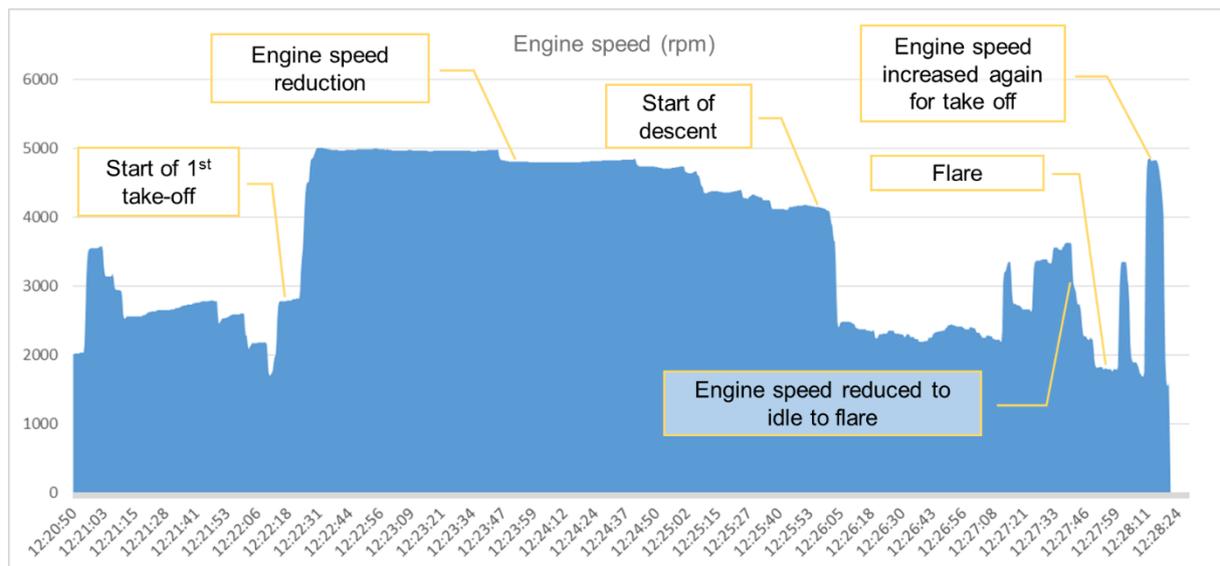
The aircraft's engine was operating normally before the accident (*Figure 5*). During the take-off ending up in the accident, the engine was running at the correct speed.

In the last third of the descent phase, a range of engine speed rise can be seen. Based on the IC's experience, in this flight phase, a thrust increase by the student pilot is seen to correct the low attitude approach, which is a phenomenon that often occurs during the approach in powered aircraft. After the flare, the diagram shows an abnormal rpm rise and then fall for about 6 seconds, which was not shown in the rpm data of previous traffic pattern flights. Based on a comparison of data, the IC identified the thrust increase as a result of the student pilot's haste resulting from exhaustion. The right side of the diagram shows the power increase to maximum and the engine stop after impacting terrain.

Figure 5: Engine speed diagram as a function of time during the flight ending up in the accident
