# **Havarikommissionen**

## **Bulletin 2020-260**

**Accident to OY-RUX (PZL-Bielsko SZD-59 ACRO) at Vesthimmerland (EKVH) on 9-7-2020.**

**ISSUED JUNE 2021**

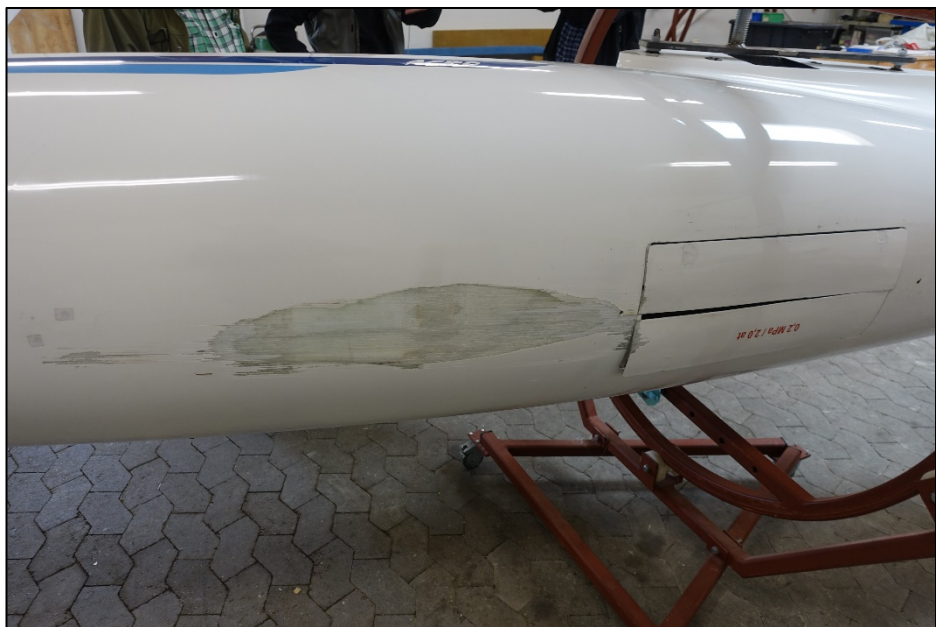
The wheel-up landing resulted in severe abrasive damage to the skin and frames of the lower part of the fuselage just forward of the wheel doors. Further abrasive damage was found on both landing wheel doors. There were no damages to the wings or the tail.

Photo no. 2: Abrasion damage to the lower part of the fuselage skin, frames and wheel doors.

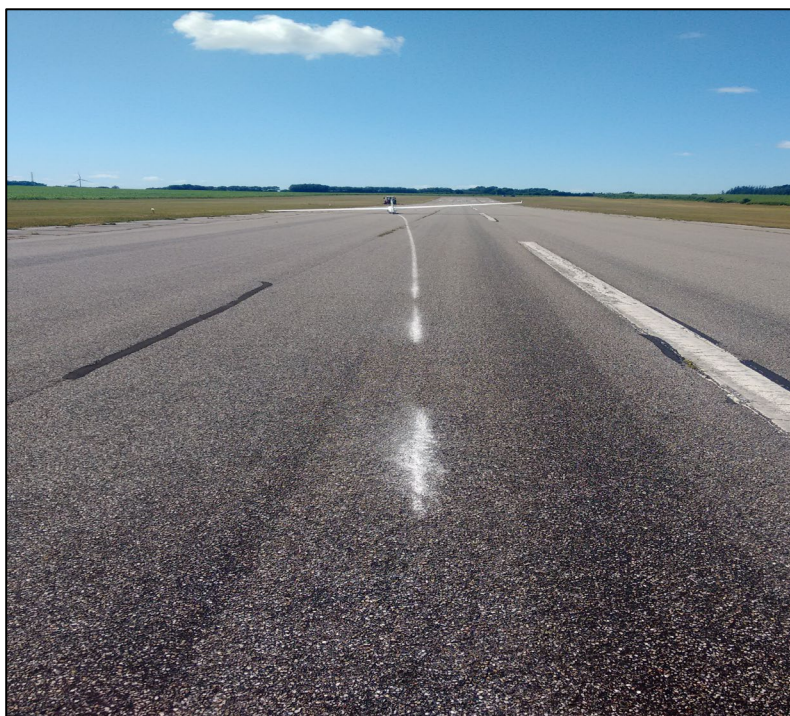
Photo no. 3: Scrape marks on the asphalt surface of runway 29.

There were no damages to the asphalt surface of runway 29. Paint and fibreglass from the glider caused white scrape marks on the asphalt.

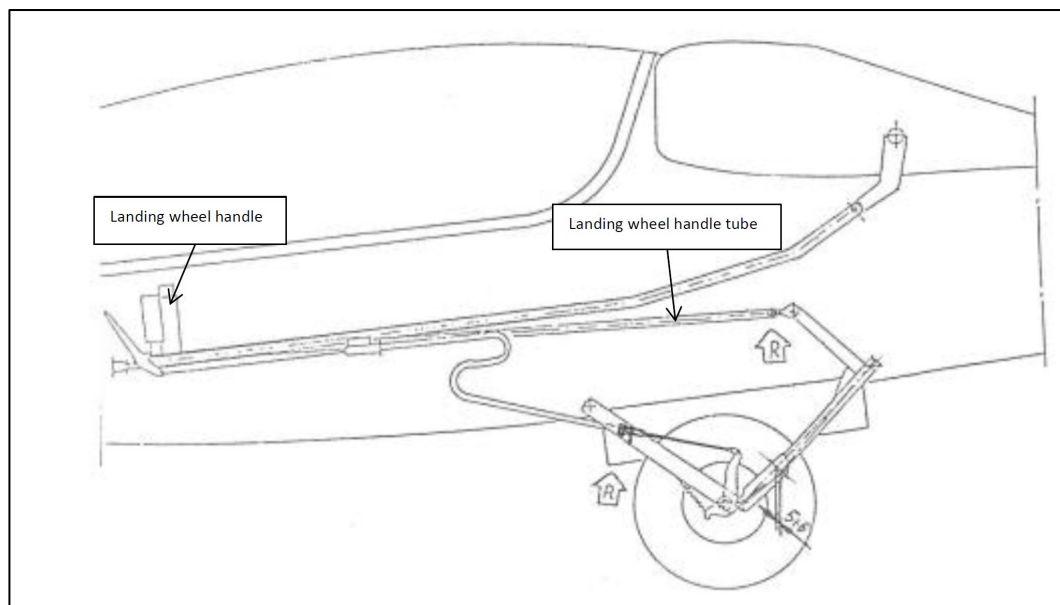
Photo no. 4: Landing wheel retraction and extension system.

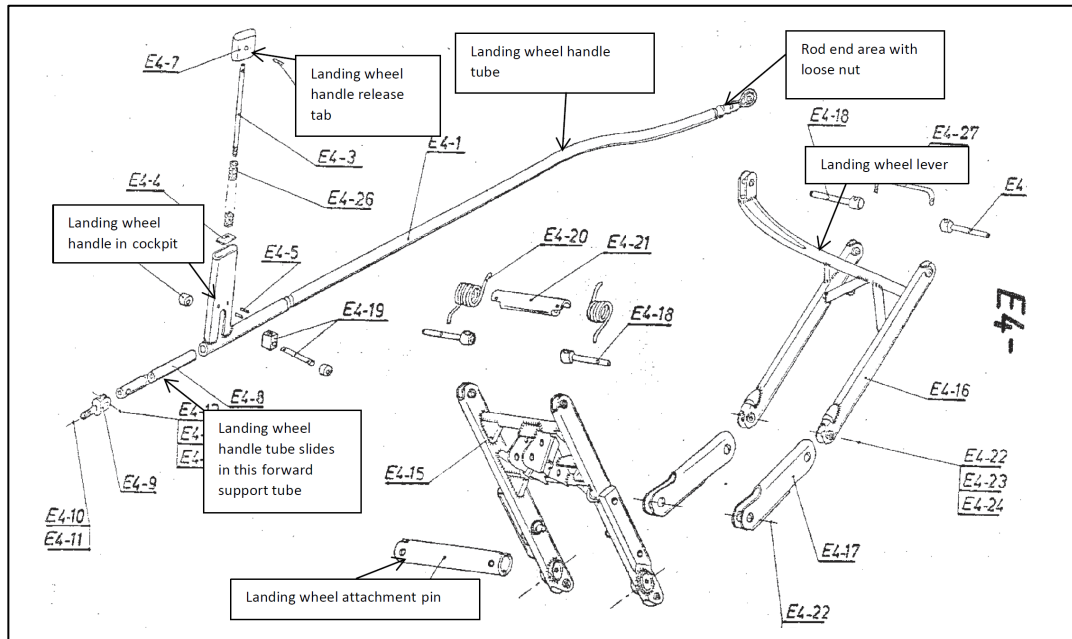
Photo no. 5: Landing wheel retraction and extension system.

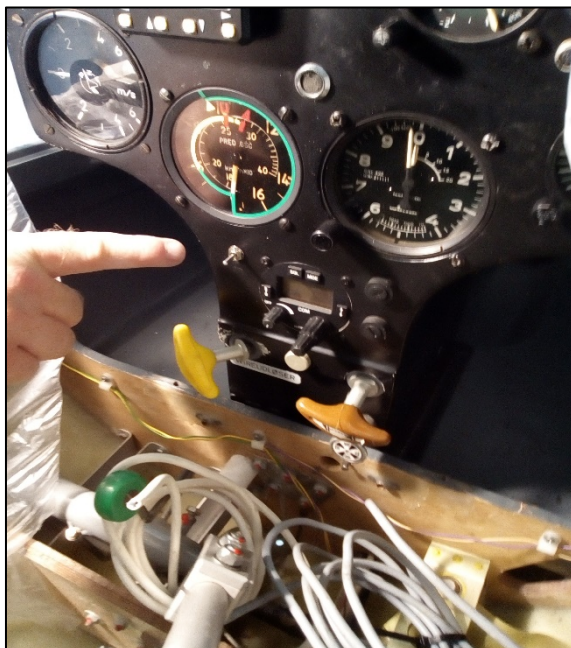
The glider was equipped with two batteries. By using a switch in the cockpit, it was possible to switch battery source between the two batteries. The label identifying the switch was missing.

Photo no. 6: Battery switch.

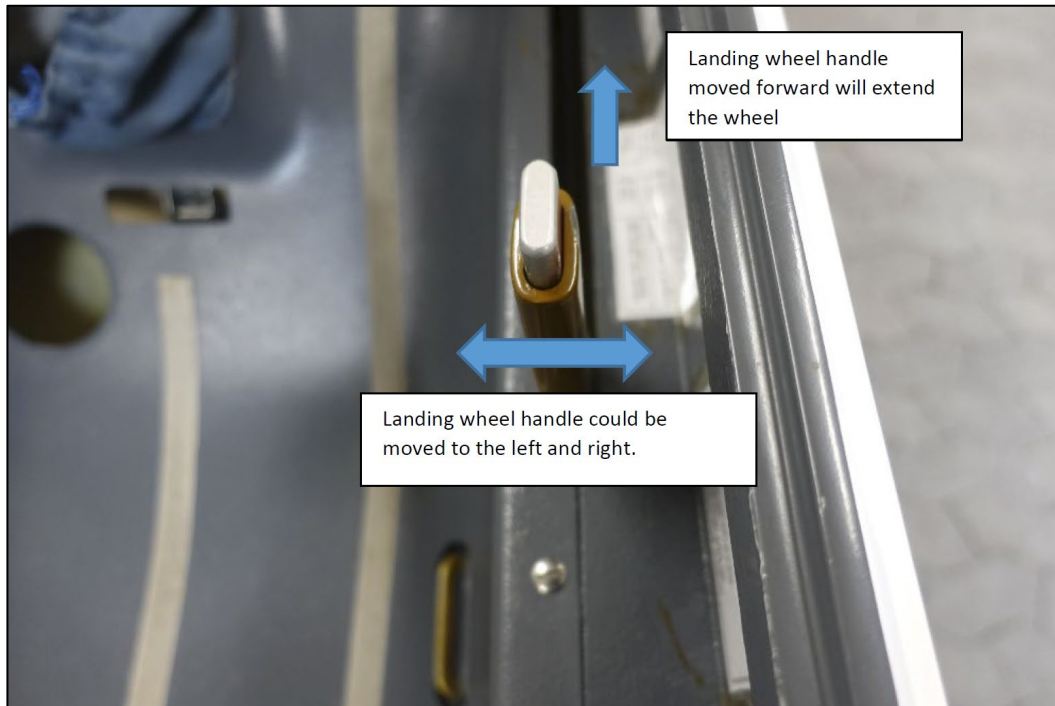
When the landing wheel handle was approximately 90 degrees to the horizontal plane, the landing wheel handle could be moved forward and aft without any jamming or binding.

The landing wheel handle could be turned some degrees to the left and right, and if so the landing wheel handle could only be moved approximately 25-30% of the complete forward travelling length, before the landing wheel handle jammed and was stuck.

During the emergency, the pilot used both hands to move forward the landing wheel handle. However, by this pilot action, the landing wheel handle was turned even more, which made the jamming worse.

Photo no. 8: Movement of the landing wheel handle in the cockpit.

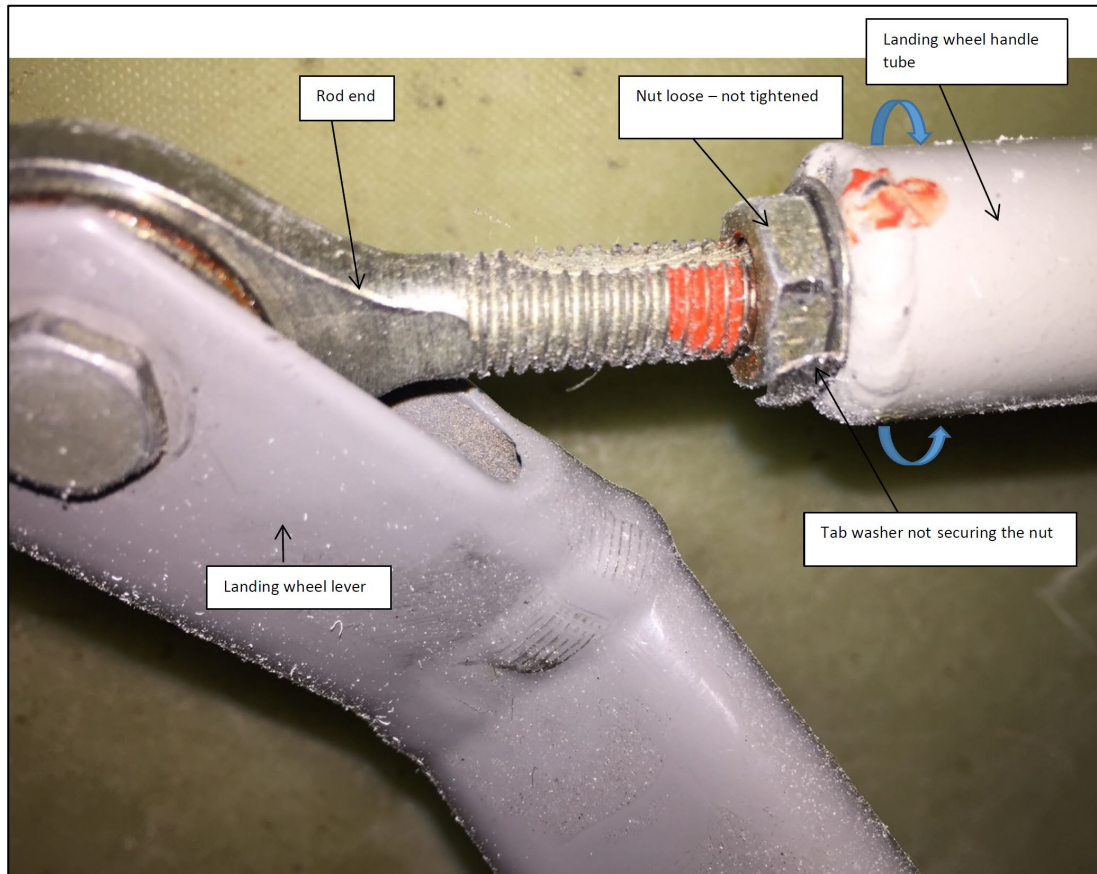
A detailed inspection of the landing wheel handle tube aft area, where the rod end was screwed into the landing wheel handle tube, revealed that the nut, securing the rod end to the landing wheel handle tube, was loose and there was a small gap between the nut/tab washer and aft face of the landing wheel handle tube. Further, the bend of the tab washer was not securing/locking the nut.

For that reason, the landing wheel handle/landing wheel handle tube could be turned to the left and right and thus restricted forward movement of the landing wheel handle.

Photo no. 9: Landing wheel handle tube rod end connection to landing wheel lever with the loose nut.

The ability of the landing wheel handle tube to rotate was caused by a loose and not secured nut used to attach the rod end to the aft end of the landing wheel handle tube.

When the nut was tightened to the landing wheel handle tube and the nut secured, the landing wheel handle tube and landing wheel handle could no more be rotated to the left and the right allowing the landing wheel to be retracted and extended without any problems.
