INTERIM STATEMENT No 2

OCCURRENCE No – 67/18

AIRCRAFT– BOMBARDIER DHC-8-402, SP-EQG

DATE AND PLACE OF OCCURRENCE – 10 JANUARY 2018, EPWA

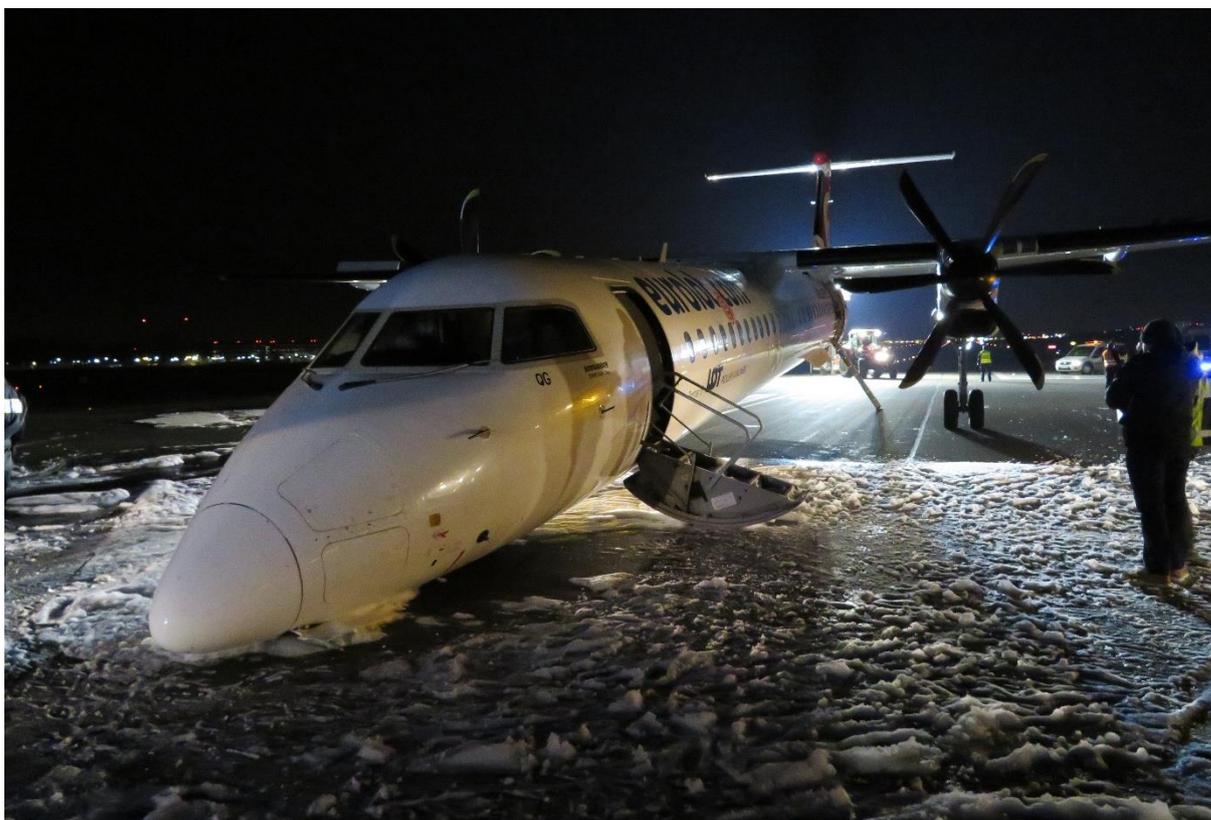
On EPWA the crew performed an emergency landing on RWY11 with NLG in the unlocked position. NLG collapsed during the landing roll. When the airplane came to rest on RWY11 at 19:19 LMT the crew evacuated the passengers. None of the passengers or crew was injured during the evacuation. The airplane was damaged to the extent requiring repair.

Fig. 1. DHC-8-402 SP-EQG after emergency landing on EPWA RWY11.

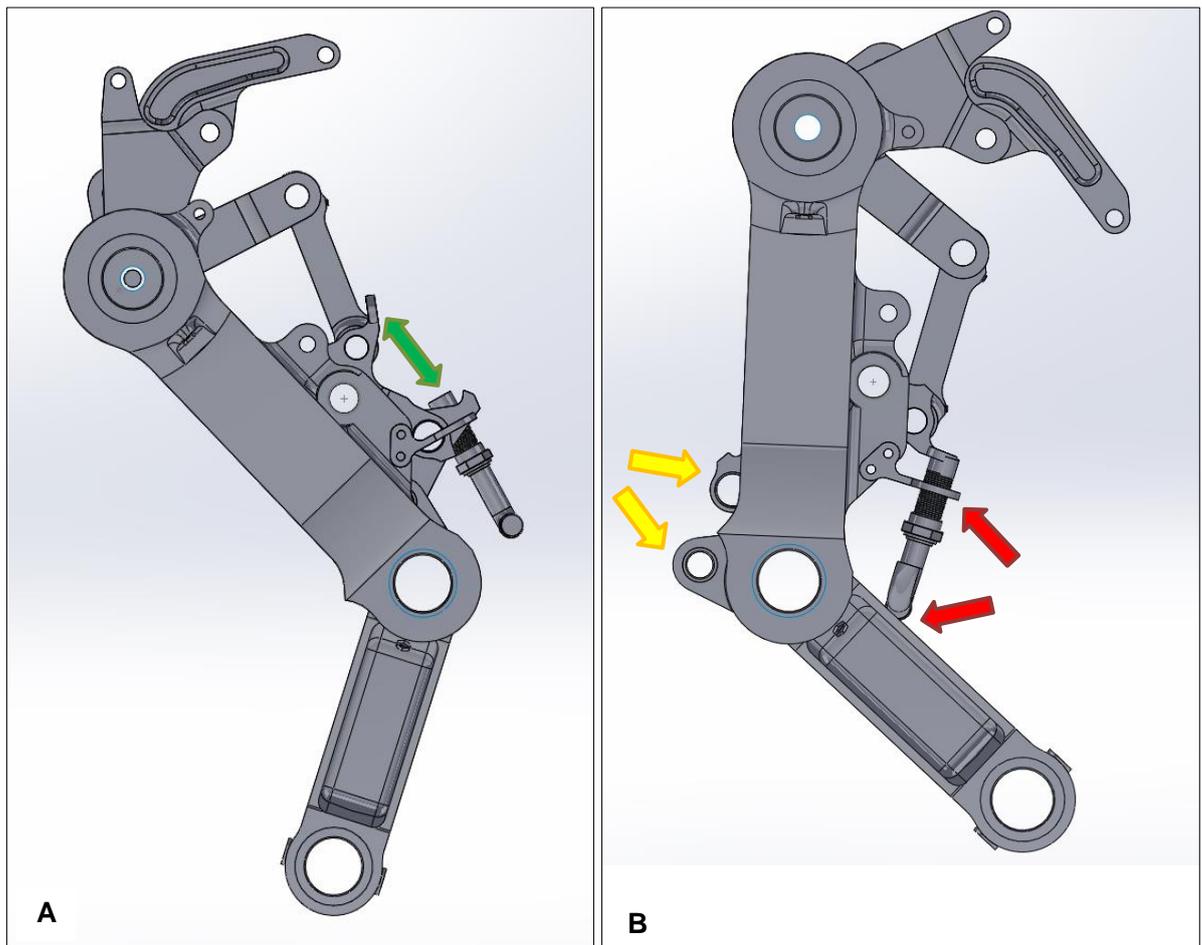
As part of the investigation, the Commission requested the Air Force Institute of Technology in Warsaw (ITWL) to carry out examination of the DSA kinematics and the damage to the DSA. As a result of the above examination, it was found that during retraction of the landing gear after take-off from EPKK, NLG DSA folded in aft direction, opposite to the intended by a designer (Figure 2-B).

Fig. 2. NLG DSA in a transitional position during NLG retraction (side view): A - correct direction of the strut folding, B - reverse direction of the strut folding [source: ITWL expert opinion, figure modified by PKBWL].

In the figure above, the green arrows indicate NGLK2 PS face moving away from the target when DSA is folding in the right direction, the red arrows indicate collision areas

when DSA collapses in the opposite direction and the yellow arrows show disconnection of the link between the LLL and LDS (link which was damaged).

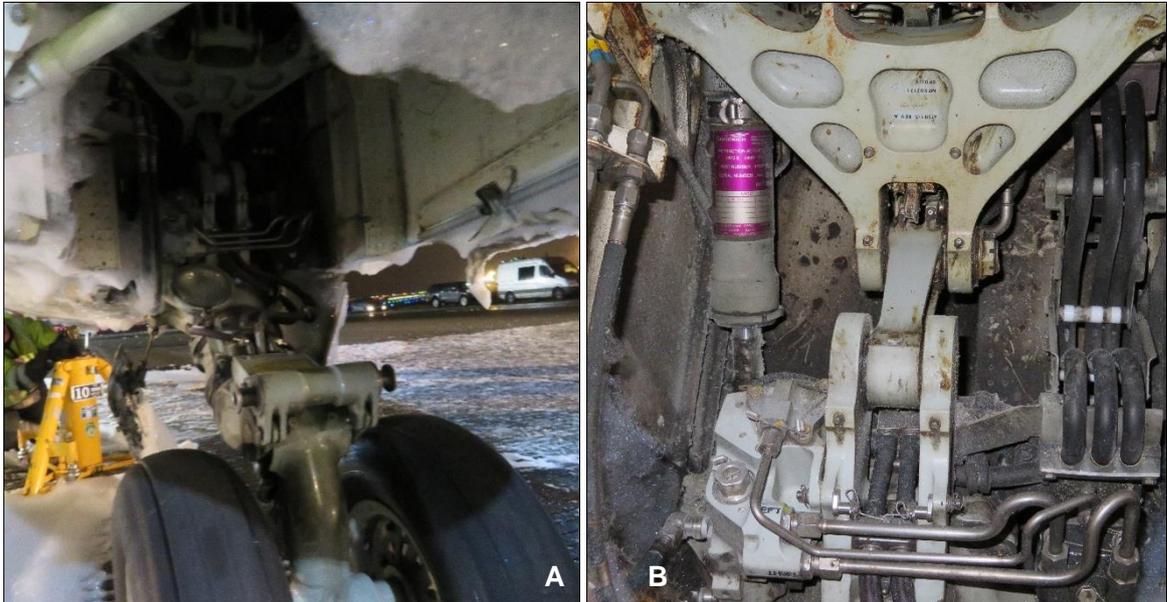
During retraction of the NLG the Drag Strut Assembly is folding in such a way that the articulated joint connecting the Lower Drag Strut (LDS) and Upper Drag Strut (UDS) is moving in the aft direction. Fig. 3 (A, B) below shows the correct location of LDS in relation to UDS after the investigated landing.

Fig. 3. Lifting the airplane – relative location of the Lower Drag Strut and Upper Drag Strut: A – general view, B – close-up [source: SCAA].

When lifting the airplane, it is not possible to move the above mentioned joint from the forward position to the aft position. Folding of the strut in the opposite direction is possible only when the Drag Strut Assembly is completely straight and free. If folding of the brace in a particular direction is initiated during landing, it is impossible to change this direction.

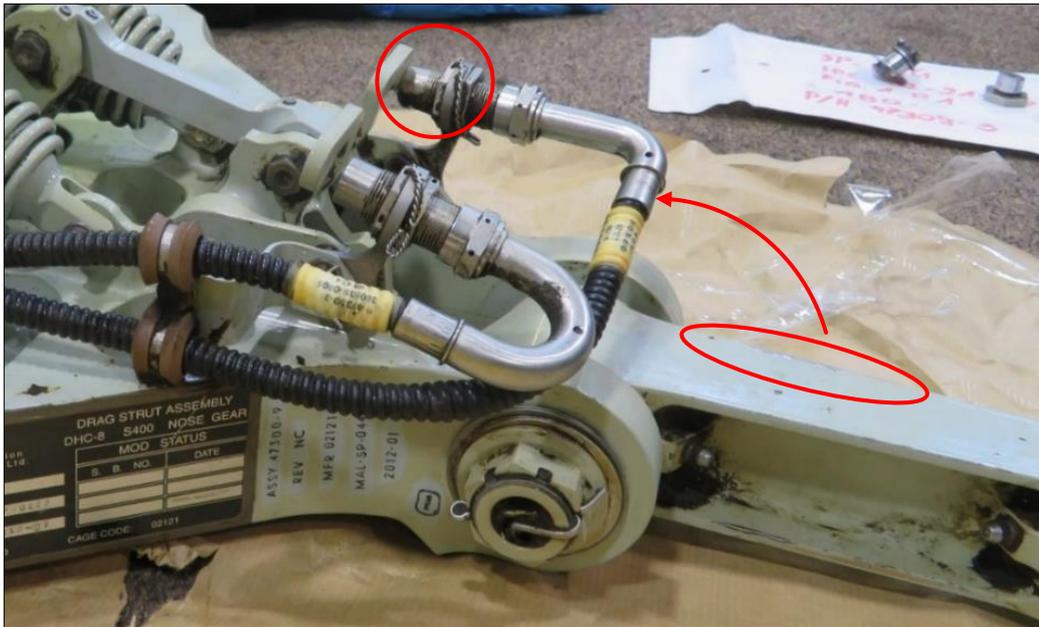
After disassembling the Drag Strut Assembly from the aircraft its detailed inspection was carried out, which showed that the Lower Drag Strut, Electrical Harness and NGLK2 Proximity Sensor face – its target, presented corresponding signs of mutual contact – Figures 4-6.

The collision of the above elements was possible only if the strut was folded in the wrong direction (forward) - therefore the damage did not occur during the landing

Fig. 4. Drag Strut Assembly - the red circle shows the place of the Proximity Sensor (NGLK2) collision with its target. The red ellipse shows the loss of the paint coating on the Lower Drag Strut and the arrow shows the direction of movement [source: SCAAI].

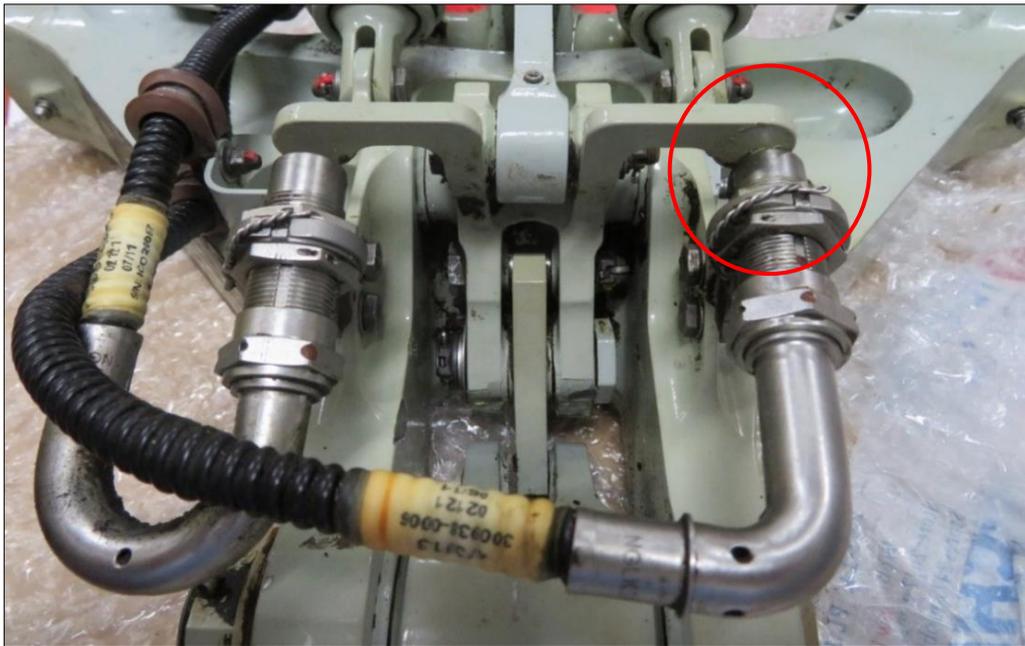
Fig. 5. Drag Strut Assembly – the red circle indicates the collision of the Proximity Sensor (NGLK2) with its target [source: SCAAI].

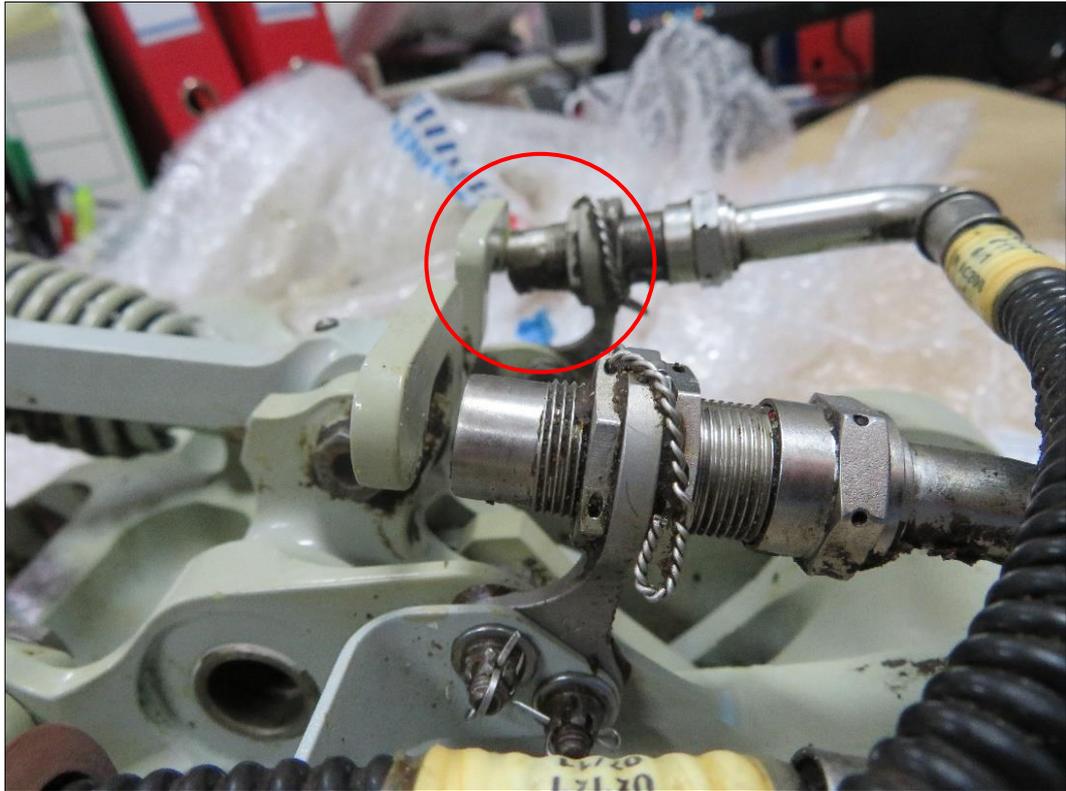
Fig. 6. Drag Strut Assembly – the red circle indicates the collision of the Proximity Sensor (NGLK2) with its target [source: SCAA].

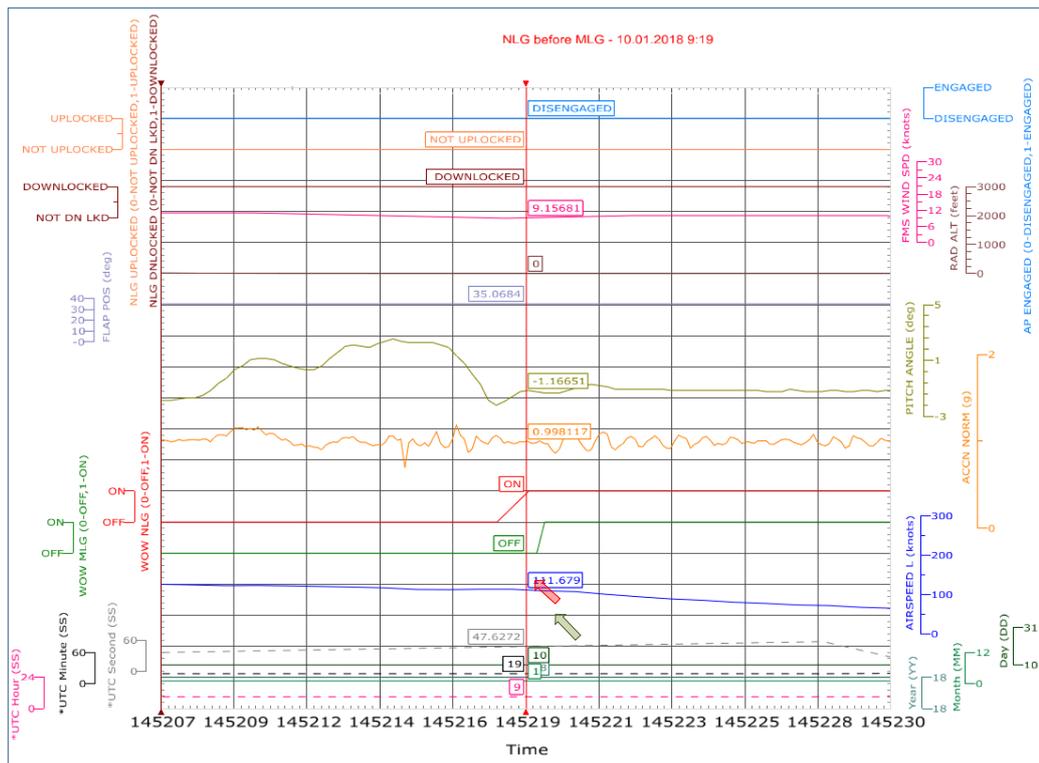
Analysis of the recorded data for SP-EQG showed that in addition to hard landings, there were also numerous cases of landings when the NLG sensor first responded, followed by the MLG sensor. The data from 1 January 2017 to the day of the accident were analyzed and they showed that there was 69 such cases (including one from the morning of the accident day), out of 2854 landings in the analyzed period. A common feature for the abovementioned 69 landings, apart from the order of the sensors loading, was a negative pitch angle.

Fig. 2. Illustration of flight parameters during SP-EQG landing on 10 Jan 2018 at 9:19 hrs UTC. The red arrow shows the time when the weight was put on the NLG, and the green arrow shows the time when the weight was put on the MLG [source: SCAA with Insight 4.91].

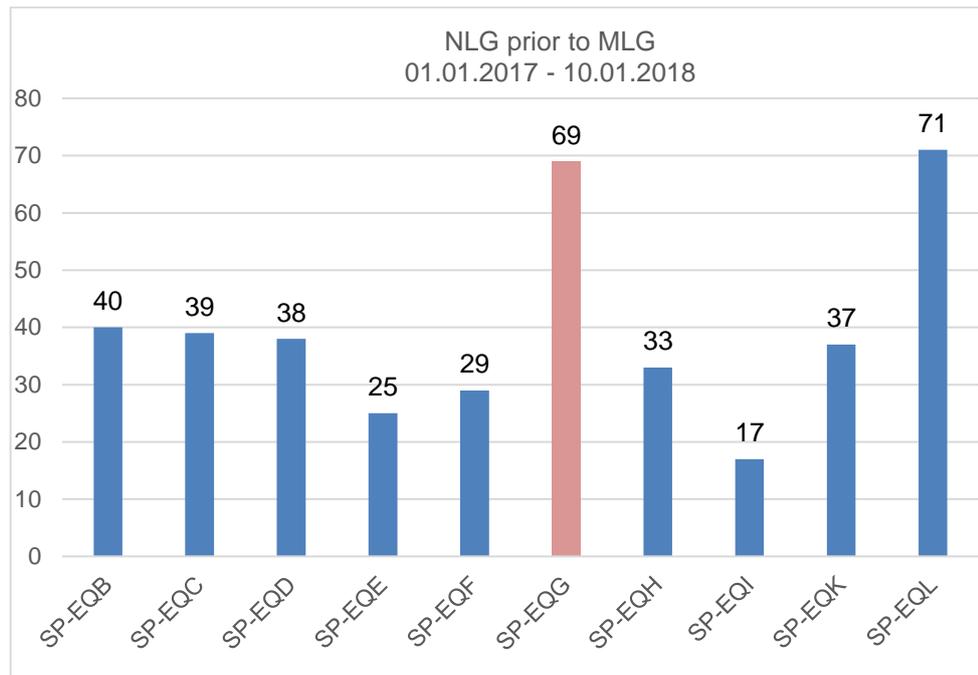
The analysis showed that there were 398 landings (on ten Q400) which had met the above conditions and that two aircraft significantly deviated from the average, including SP-EQG (see Fig. 8).

Fig. 8. Number of landings with weight on NLG signaled prior to weight on MLG – SP-EQG marked with claret color.

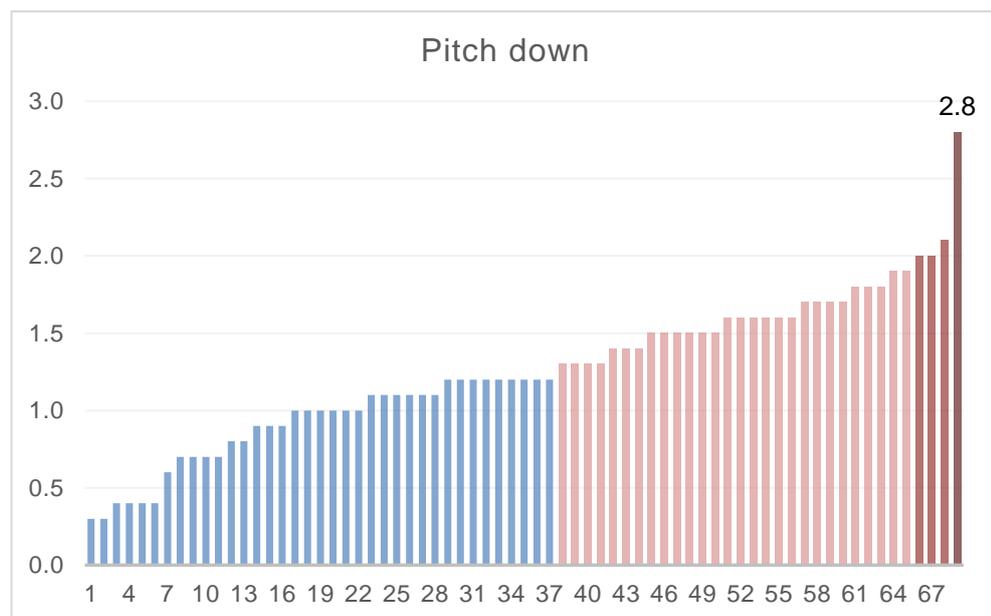
The data also showed that 32 landings occurred at the pitch angle (PA) greater than 1.2⁰ nose down.

Fig. 9. Negative pitch angle during landings, when weight on NLG was signaled prior to weight on MLG - claret and brown colors show landings with “nose down” pitch angle of 1.3° and above.

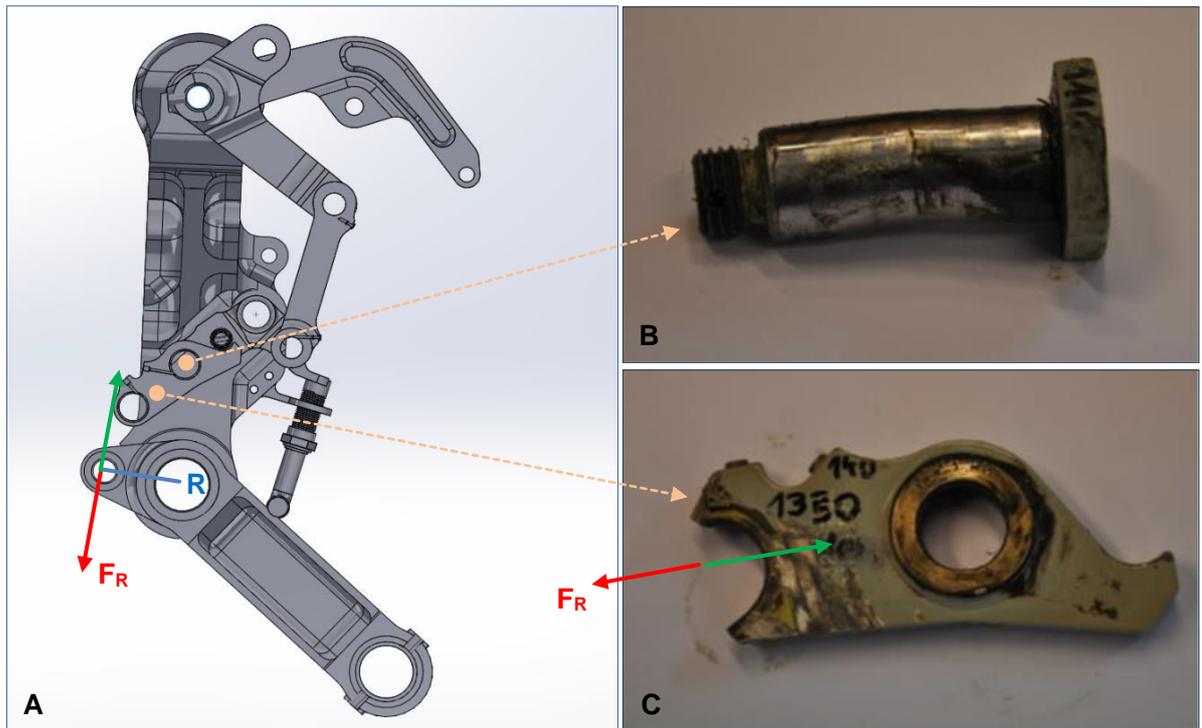
When LDS and UDS were folding in the wrong direction, the MR moment (FR force x R arm) was acting on LLL (through the pin connecting LLL and LDS) – Fig. 10, red arrows.

The moment (FR force) had a tearing effect on LLL at its smallest sectional area, which is confirmed by the nature of the damage shown in Fig. 10-C.

During proper retraction of the NLG, the acting force would have the opposite direction (green arrows), therefore it could not have caused any damage.

Fig. 10. Nature of damaging the NLG strut during incorrect retraction of the NLG - cross-section in the longitudinal plane: A - LDS collision with ELH, B - bent pin (axis of LLL rotation), C - damaged LLL.

Damage (bending) of the LLL pin (Fig. 10-B) indicates that the system was subjected to a great force while LLL movement was blocked, which occurs when LLL rests on the stop pin. Such conditions may occur when NLG is down and locked.

The LLL rests on the stop pin also when the NLG is completely retracted, but then the NLG system is not affected by any external force and in the investigated occurrence the NLG was not retracted.
