# FINAL REPORT

Aero AT-3R100, HA-NAD  
Tököl Airfield (LHTL), 26 August, 2023

Accident  
2023-1178-4

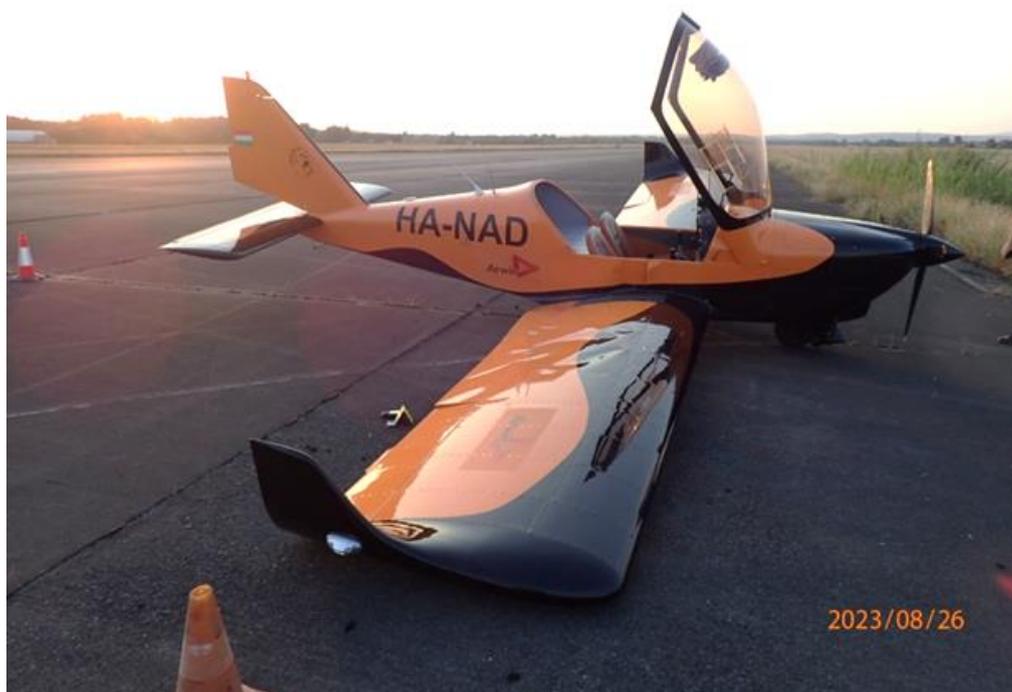
The Investigating Committee of the Transportation Safety Bureau (hereinafter referred to as 'IC') attributed the occurrence of the accident to human factors. During the investigation, the IC concluded that the direct cause of the accident was the pilot increasing the aircraft's pitch angle after take-off to a critical value, causing the aircraft to stall. Additionally, the IC identified a contributing factor.

Figure 1: Aircraft at the scene of the accident
