# Quarterly Aviation Report

July - September 2023

Q3 2023

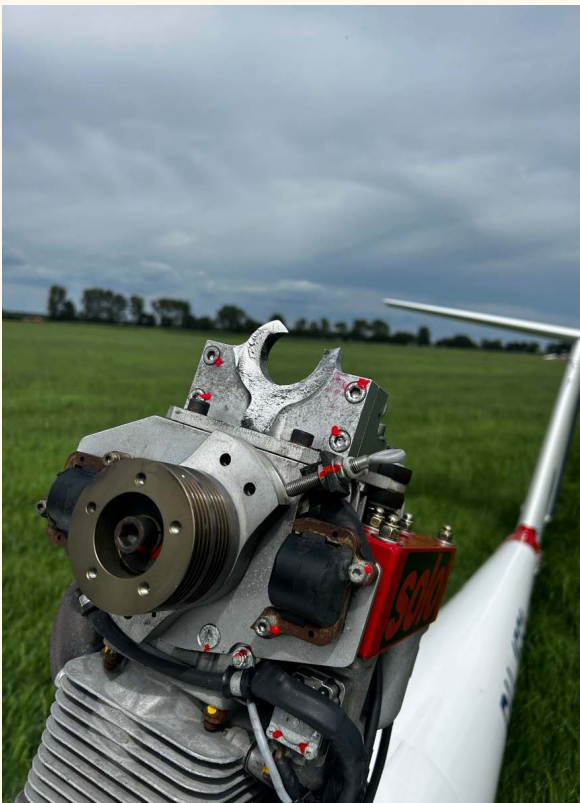
After the pilot had started the glider's turbo engine and subsequently climbed to approximately 300 metres, the propeller became separated from the engine. The glider made a safe landing at Lemelerveld glider airfield.

▼ The turbo engine without propeller. (Source: gliding club)

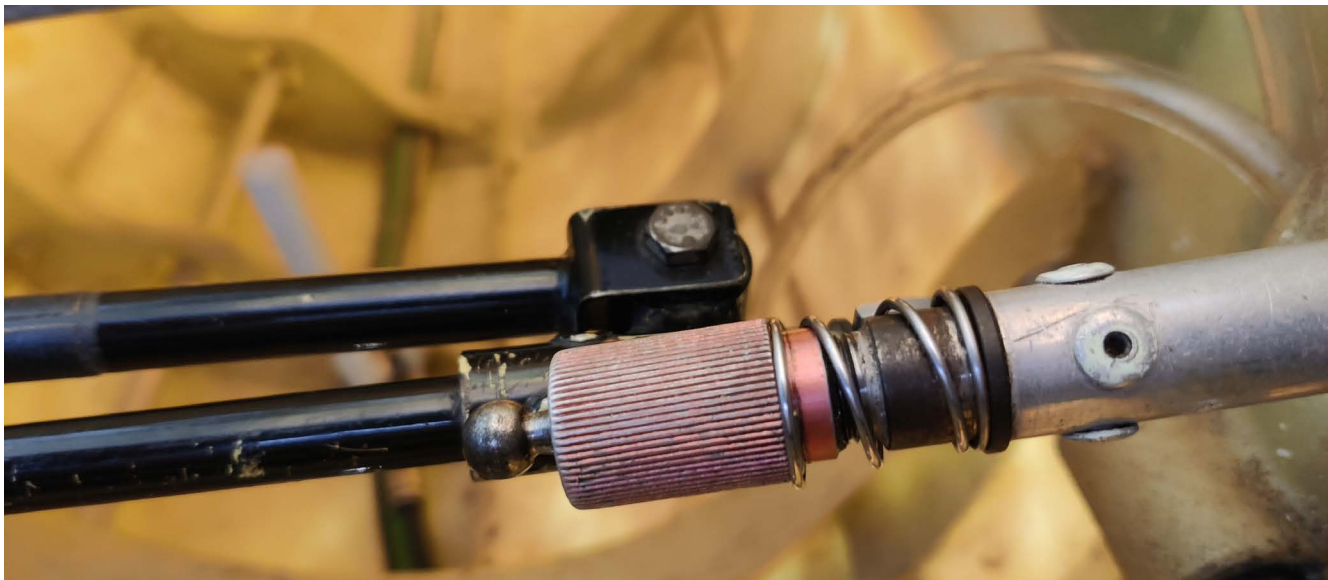
▲ The loose L'Hotellier control connection. (Source: pilot)

The glider's left aileron started to flutter while making a turn. The pilot stated that the left wing also moved up and down and that he temporarily lost control of the glider. Several seconds later, he regained control and decided to land the glider. Increasing the speed a little made the glider controllable. The glider made a safe landing. Inspection showed that the left aileron L'Hotellier control connection was loose.

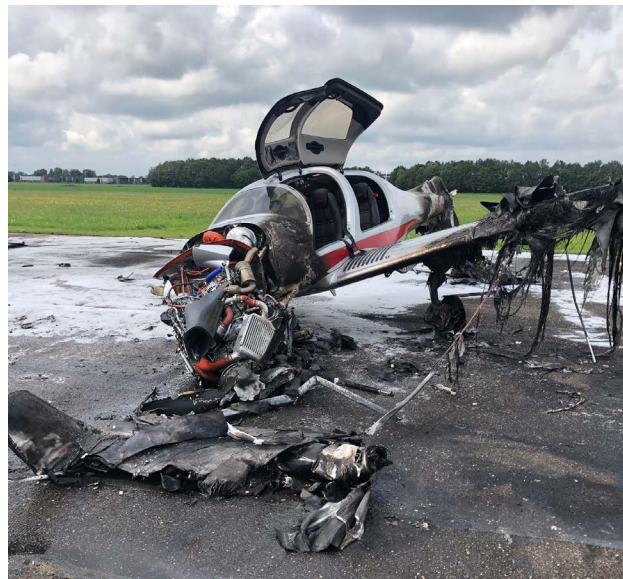
▲ The aircraft after the fire had been extinguished.

The pilot reported that the engine power briefly decreased twice shortly after takeoff from Runway 21. The pilot decided to return to the airfield. Subsequently, the engine lost power completely at the start of the downwind leg. The pilot then started the approach to Runway 03. The aircraft landed hard on the ground next to the runway, thereby causing the right wing to break. The aircraft then made a ground loop and came to a standstill on the runway. The pilot was able to disembark independently and suffered minor injuries. The aircraft's left wing, tail and engine caught fire for several minutes before being extinguished by the fire brigade.

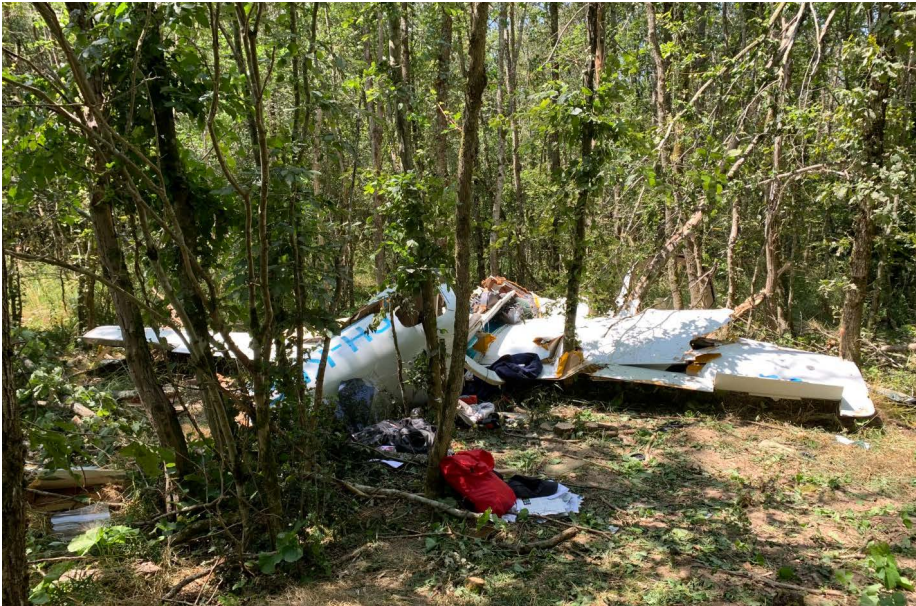
The aircraft, carrying a pilot and a passenger, was making a flight from Karlsruhe/Baden-Baden Airport in Germany (EDSB) to Mulhouse-Habsheim Airport in France (LFGB). The aircraft crashed in the woods near Habsheim. Both occupants were killed.

◀ The aircraft wreckage.  
(Source: BEA)

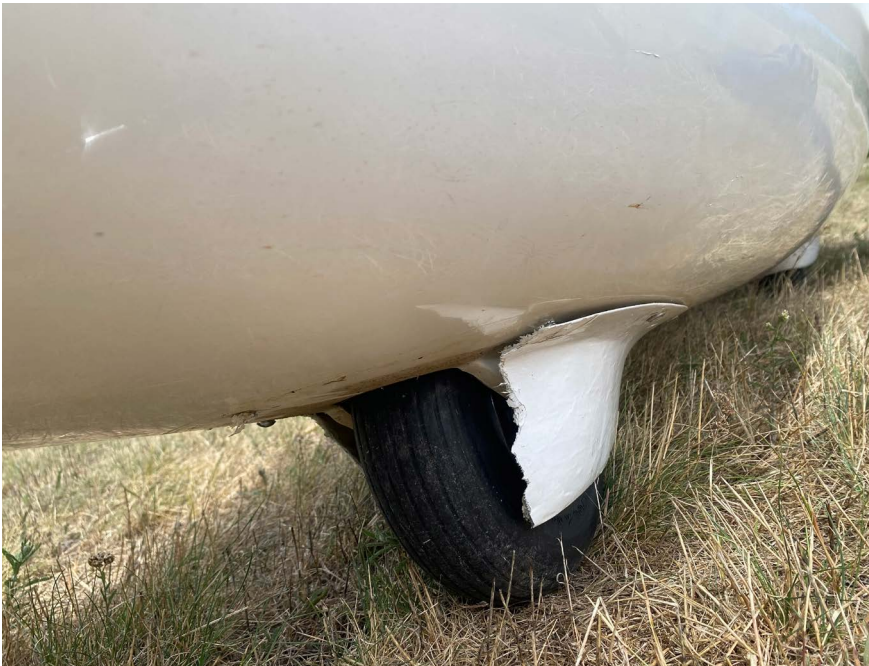
The glider, with an instructor and trainee on board, landed further away on the grass runway because it was full of other aircraft. During the landing roll, the instructor took over the controls and steered the glider to the edge of the runway, clearing it for an approaching motorised aircraft. After leaving the runway and crossing a dirt road parallel to the runway, the nose wheel hit a marker stone lying in the grass. As a result, the fairing and suspension of the nose wheel sustained damage.

▼ Damaged nose wheel fairing. (Source: pilot)

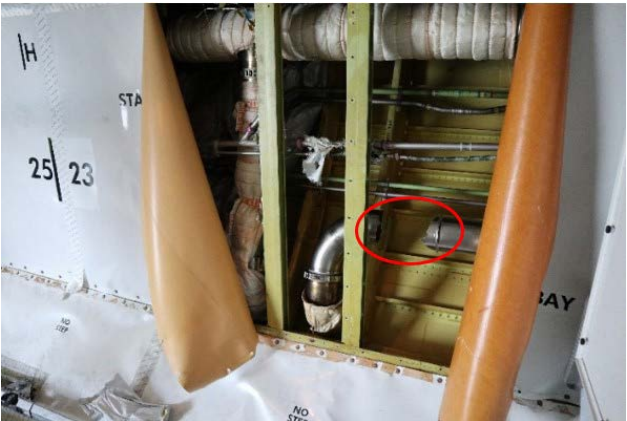
Investigation revealed that a titanium pneumatic duct (see photo), located in the left sidewall near the aft cargo compartment, had ruptured. The material insulating the duct was also damaged, which resulted in dust and debris from ducting insulation entering the passenger compartment through the ventilation outlets near the passenger floor.

According to Boeing, the duct is wrapped with a high temperature air duct insulation blanket. In addition to the insulation around the duct, there were insulation blankets along the interior of the fuselage adjacent to the duct rupture. All insulation material used in the area of the rupture is fiberglass-based insulation material.

▲ Ruptured pneumatic duct.

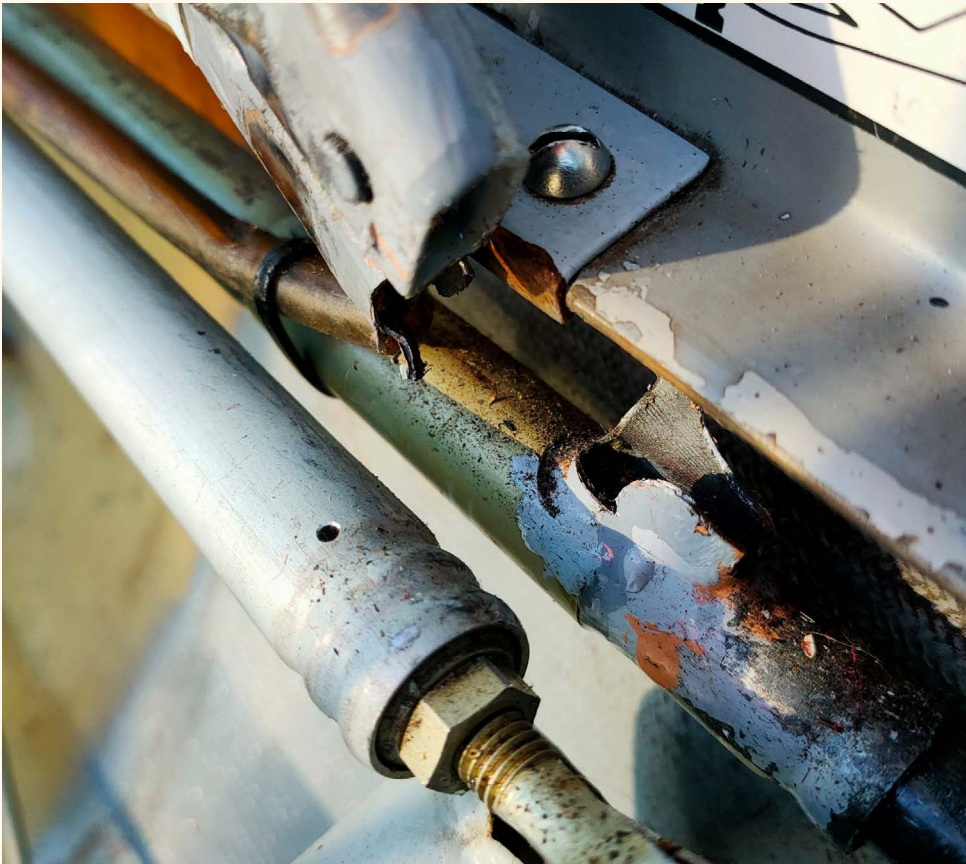
◀ The broken airbrake lever.  
(Source photograph on the left: gliding club)

The airbrake lever, which had been in the glider since its construction in 1993, had a fracture in the handgrip. The fracture was a short distance from the weld with the rod of the lever. Material examination showed that the airbrake lever broke off as a result of fatigue. The fatigue appeared to have started at the interior surface. The exact initiation point could not be determined, however. No material defects were identified. The fatigue was probably the result of standard use of the airbrake lever. During the pilot's pre-flight inspection, prior to the flight in question, and during the

routine maintenance of the glider, nothing unusual was found with regard to the operation and condition of the airbrake lever. The gliding club stated that the original lever was never removed for a repair, but there may have been a minor paint repair. The manufacturer stated that they were not aware of any similar incidents.

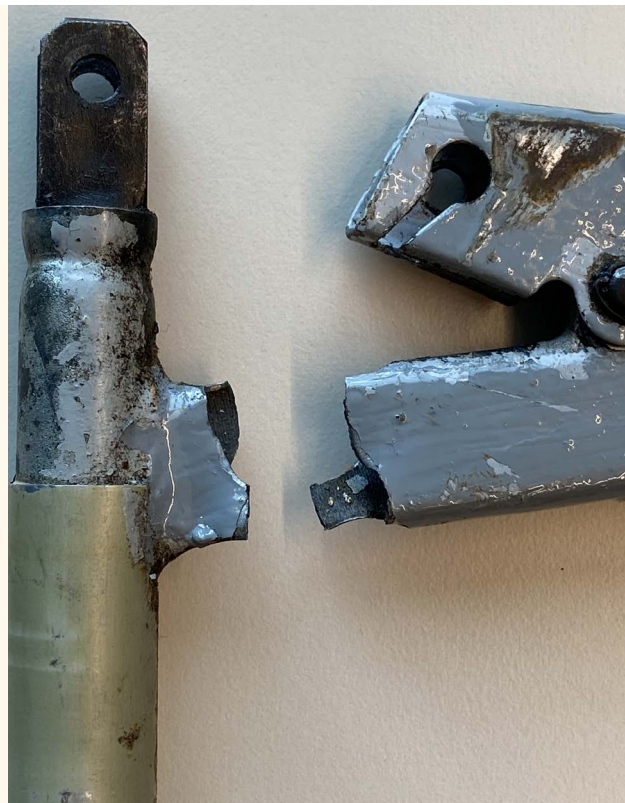
► *The broken airbrake lever.*

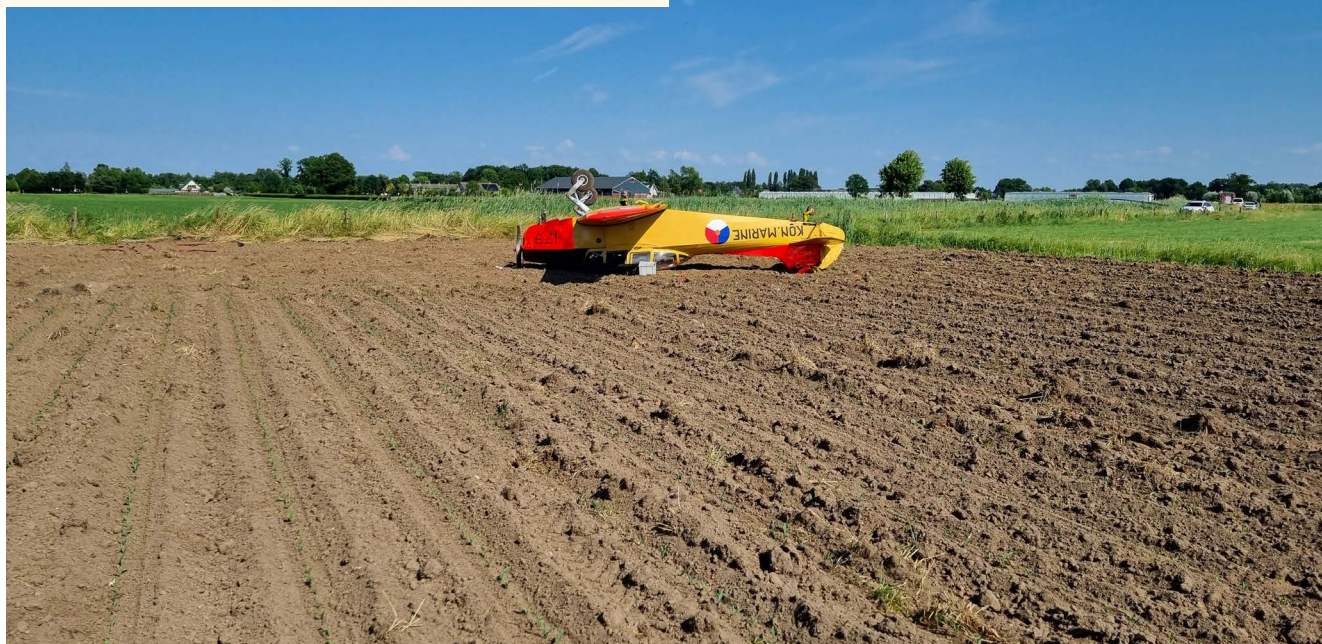
▼ The Fokker S.11.1 in the field.  
(Source: Dutch Aviation Police)

The technical examination carried out by the owner showed that the engine mounting was bent and the engine controls no longer functioned fully. Further investigation has not yielded any information that could explain the cause of the engine problem. The lock mechanism of the mixture handle no longer functioned due to wear. This may have caused the mixture control to partially move from "rich" to "lean", causing the engine to receive too little fuel and a loss of power.

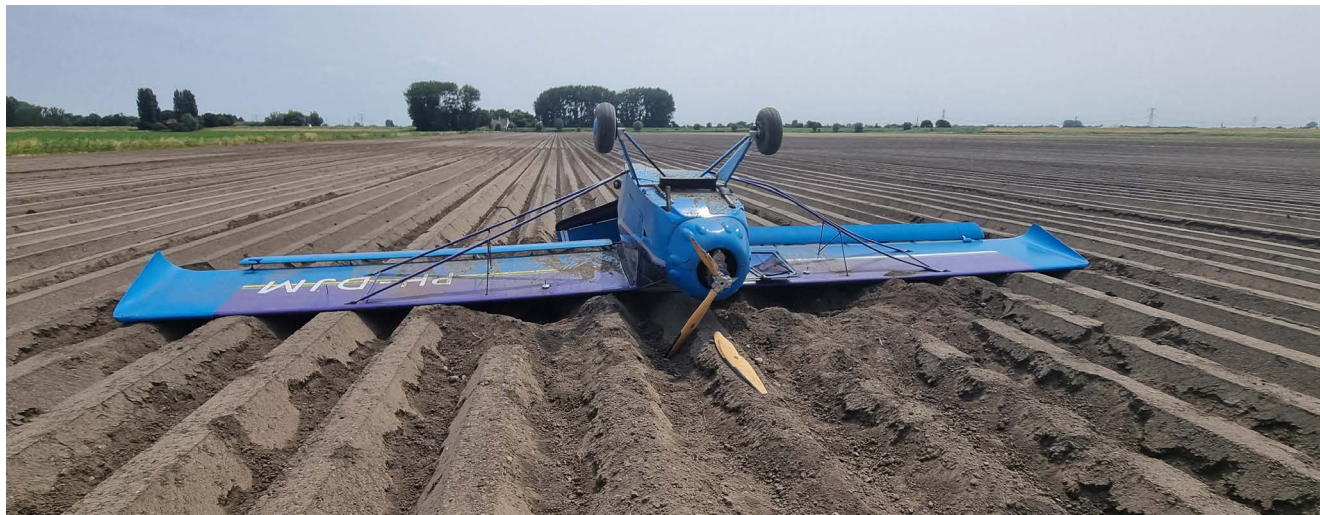
▲ The aircraft after the emergency landing. (Source: Dutch Aviation Police)

The pilot took off from Breda International Airport (EHSE) for a local flight. Near Drimmelen, the pilot gave less throttle, after which he heard a loud bang. Subsequently, the engine power decreased. The engine vibrated heavily and more loud bangs followed. The engine power was insufficient to maintain altitude and speed, upon which the pilot initiated a descent to maintain speed. The pilot decided to make an emergency landing in a field and made a mayday call on the frequency of Dutch Mil. After the emergency landing was initiated, the aircraft landed in a potato field. Because of the loose soil, the aircraft nosed over during the emergency landing and came to rest inverted. The pilot was uninjured and was able to leave the aircraft on his own.

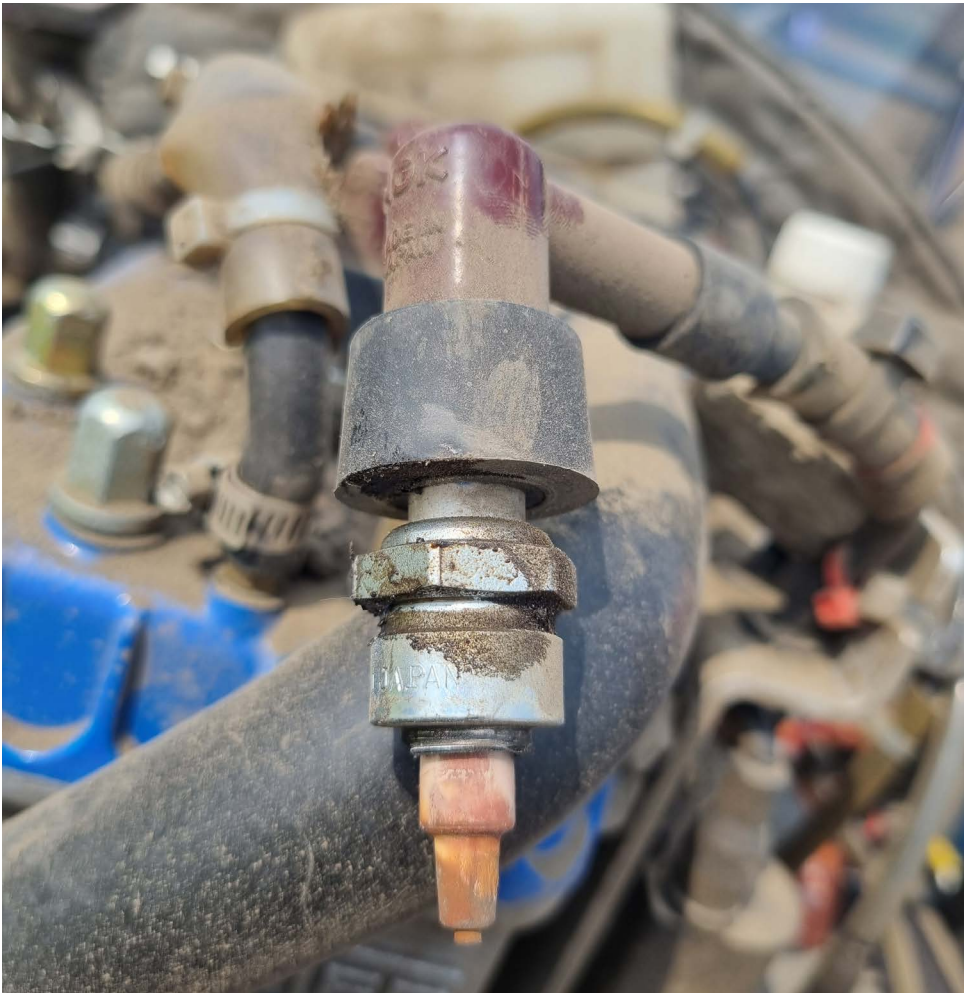
Investigation of the engine after the accident revealed that one of the four spark plugs of type BR8ES was broken in the middle. The upper part (with the isolator) was found loose from the cylinder, hanging from the spark plug cable.

The reduction of engine power during flight was caused by the broken and loose spark plug. As a result, no ignition took place in the cylinder and an opening was created in the cylinder head causing the cylinder to lose compression. Because of this, only one of the two cylinders was delivering power. A large part of the engine power was lost. The bangs were probably caused by the piston in the second cylinder that still went up and down and the uncombusted fuel-air mixture that ignited partly in the hot exhaust manifold.

The pilot had replaced the spark plugs on 12 February 2023. According to the pilot, the engine had run 3 hours and 10 minutes with the new spark plugs without any problems, of which 2 hours and 25 minutes flying time, including multiple full power takeoffs. The cause of the failure of the spark plugs was not further investigated.

◀ The failed spark plug.  
(Source: Dutch Aviation Police)
