RELATÓRIO SUMÁRIO DE ACIDENTE COM AERONAVE

AIRCRAFT ACCIDENT SUMMARY REPORT

Separação inadvertida e prematura do cabo da aeronave de reboque.

PROCESSO GPIAAF // GPIAAF PROCESS ID 2022/ACCID/05	<i>Classificação // Classification</i> Acidente // Accident
	<i>Tipo de evento // Type of event</i> GTOW Eventos relacionados com operações de reboque // Glider towing related events
OCORRÊNCIA // OCCURRENCE	
<i>Data // Date</i> 11-11-2022	<i>Hora // Time</i> 12:40 UTC
<i>Local // Location</i> Sudoeste do aeródromo num campo aberto junto à estrada N114 South-West of the aerodrome in an open field close to N114 road	
AERONAVE // AIRCRAFT	
<i>Tipo // Type</i> PZL-Swidnik PW-6U	<i>N.º de série // Serial No.</i> 78.02.08
<i>Categoría // Category</i> Planador // Glider	
VOO // FLIGHT	
<i>Origem // Origin</i> Aeródromo da Amendoeira (LPMN)	<i>Destino // Destination</i> Aeródromo da Amendoeira (LPMN)
<i>Tipo de voo // Type of flight</i> Aviação Geral // General Aviation	<i>Tripulação // Crew</i> 02
<i>Fase do voo // Phase of flight</i> Descolagem // Take-off	<i>Passageiros // Passengers</i> 00

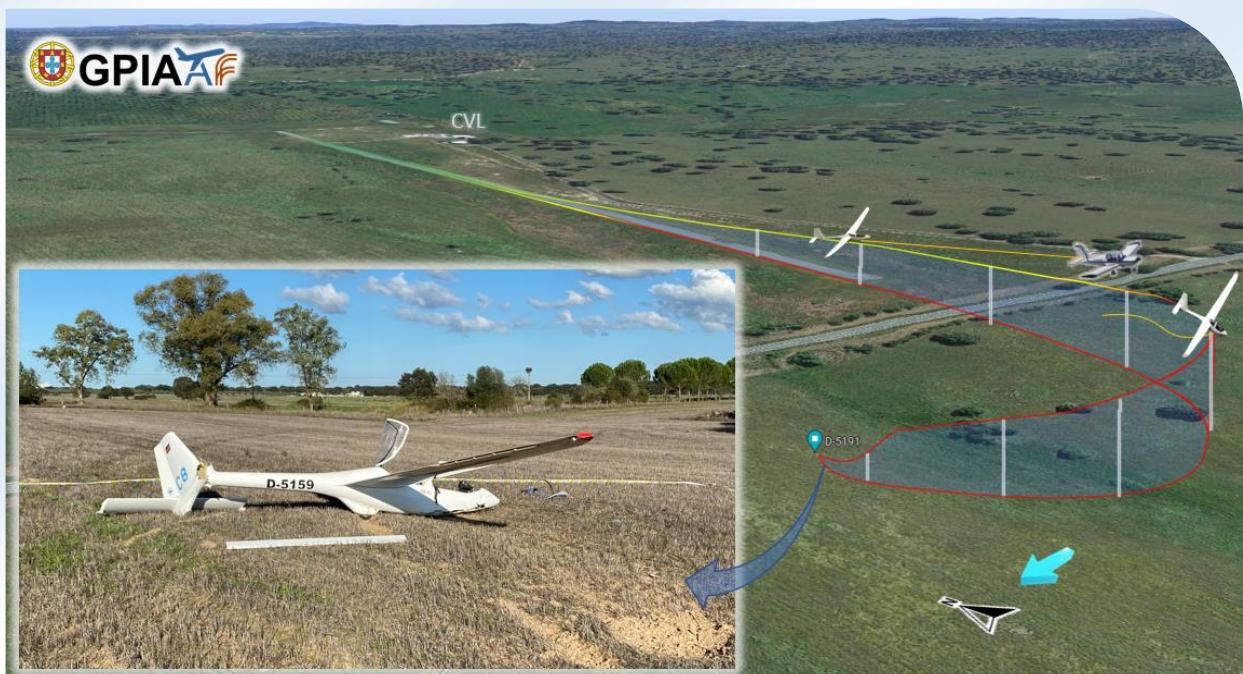
Figura 1
Trajetória de voo e posição final do planador

Logo após cruzarem a estrada (N114) já fora do perímetro do aeródromo e a uma altura de aproximadamente 25 metros, o cabo de reboque soltou-se da aeronave rebocadora (ver Figura 1).

Figure 1
Flight trajectory and final position of the glider

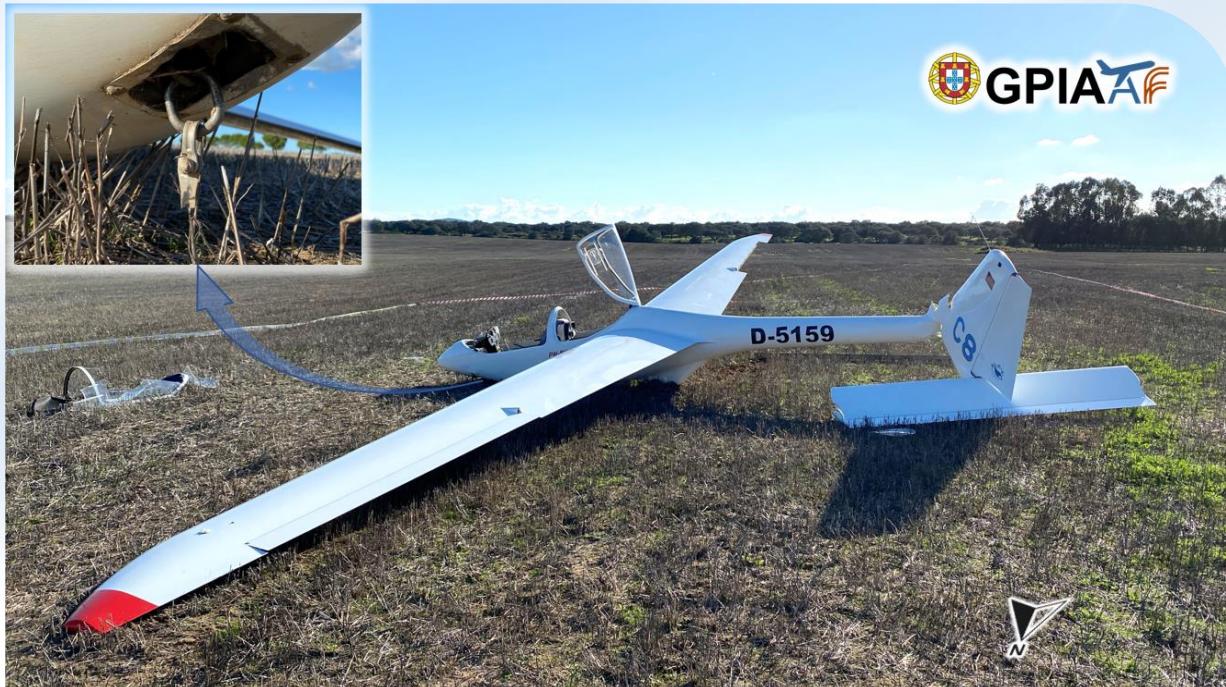
Figure 2

The glider sustained substantial damage. Initial contact with the ground occurred with the right-wing tip, where scrape marks (2.5 m in length) were visible, which resulted in the separation of the respective wing tip wheel.

Perspective of the damage sustained by the glider, against the direction of travel, facing South. Insert: Towing ring still attached following impact with ground.

During the descending motion of the glider, the right wing was bent causing permanent structural damage

to the rear wing spar and a rippling effect on the upper surface skin. This caused deformation of the attachments of the right aileron which separated from the wing as a consequence of the bending load.

The 50-meter tow rope was found nearby the glider. The glider end of the rope had failed at the weak link during the ground collision. The other end of the tow rope was stretched intact on the ground in a Southerly direction with the weak link unbroken and the attachment ring undamaged.

The other attachment ring was held in place by the Tost system tow release hook fitted in the nose of the glider (insert in the figure above). During the tests performed, applying the release handle caused the hook to operate normally and release the tow ring from the glider.

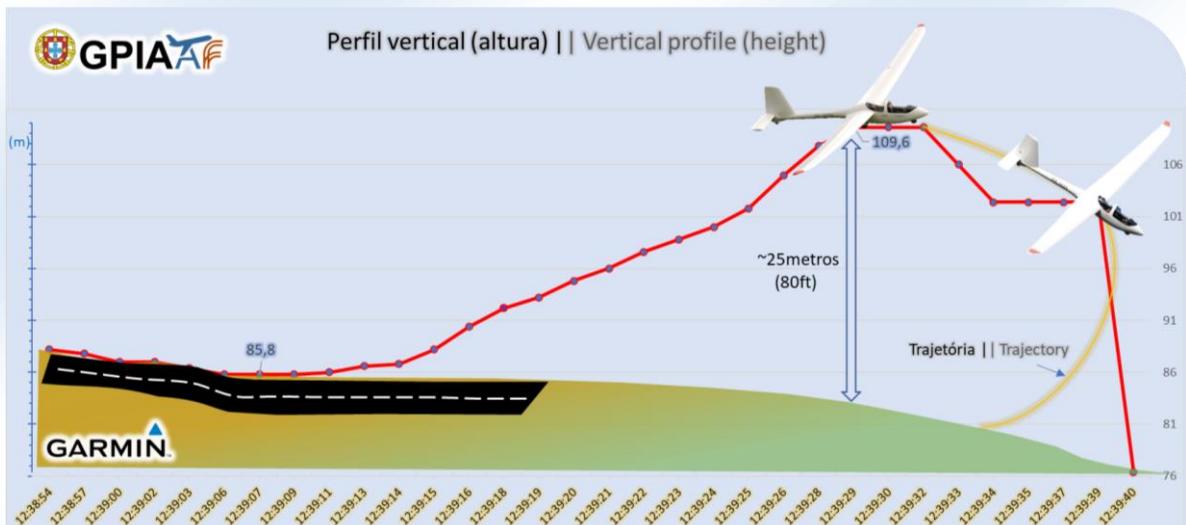
Figura 3 || Figure 3

Perfil vertical do planador durante o segundo voo

Using the data recorded by the pilot's watch, it was possible to draw an approximate vertical profile of the accident flight. Associating this data with the observed horizontal trajectory, it is possible to verify a deviation from the procedures foreseen and discussed between the instructor pilot and the student pilot in the flight preparation phase.

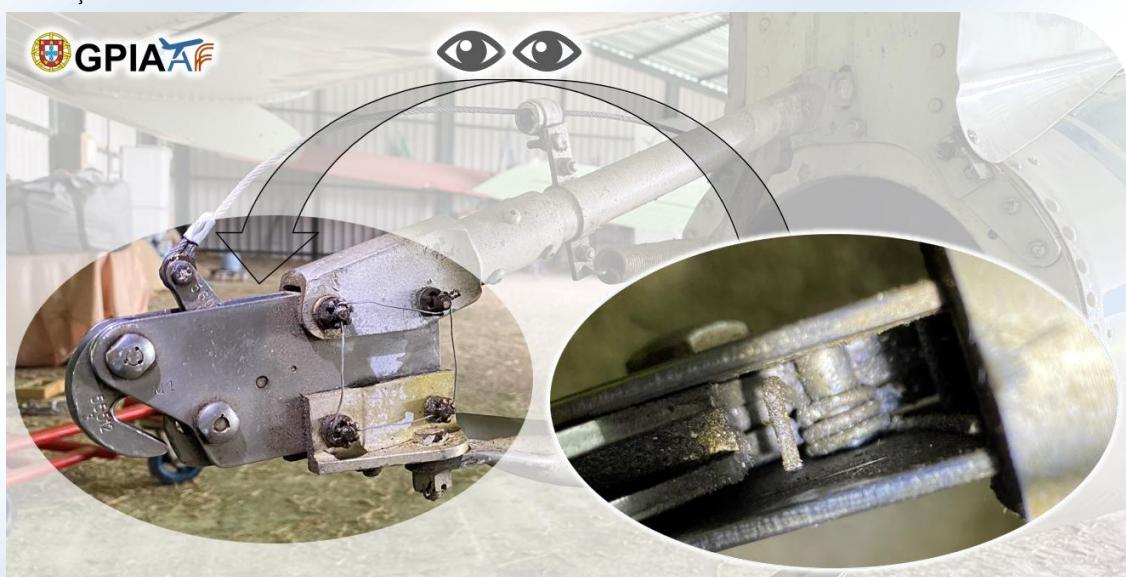
Figura 5 || Figure 5

External inspection of the hook revealed the presence of the main spring and a significant amount of dirt within and around the hook itself (see Figure 5). There was no evidence of recent cleaning or lubrication.

Vista do interior do gancho de reboque, mostrando a condição deteriorada da mola.

|| View into the towing hook, showing the deteriorated condition of the spring.

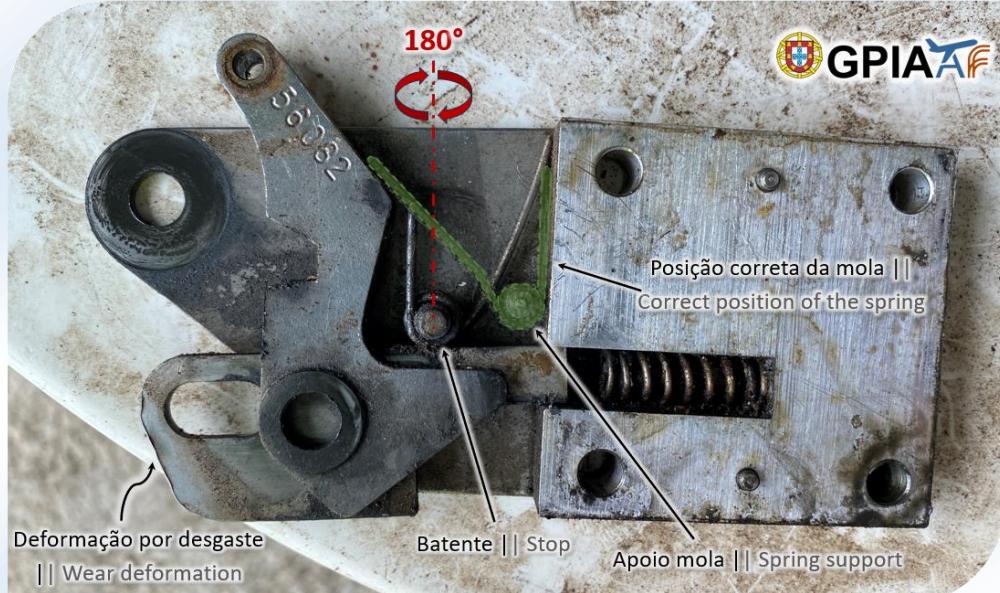
Figura 6 || **Figure 6**

Upon disassembly, it was found that the spring had been installed on the stop of the trigger instead of being further back in the correct position, on the spring support.

Furthermore, the spring had been installed in a reverse position (rotated 180°); meaning that the long arm, meant to sit on the back of the trigger, was pressing against the casing wall and the short arm was too short to make contact with the trigger (see Figure 6).

Effect of the incorrect installation was such that the spring was not making any contact with the trigger and as such not delivering the required recoil effect required to lock the hook as per the component's design.

Disposição da mola principal no interior do gancho Aerazur || Main spring arrangement within the Aerazur towing hook

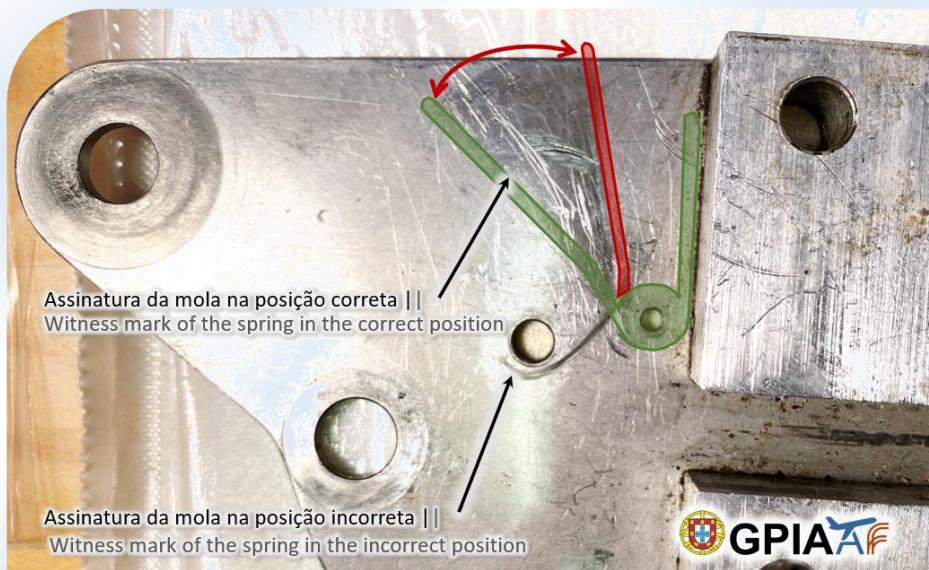
Figura 7 ||| **Figure 7**

As for the spring itself, it was found to be in a very fragile (cracked) condition and the short arm separated with very little effort.

Assinatura da mola na face interior da estrutura do gancho

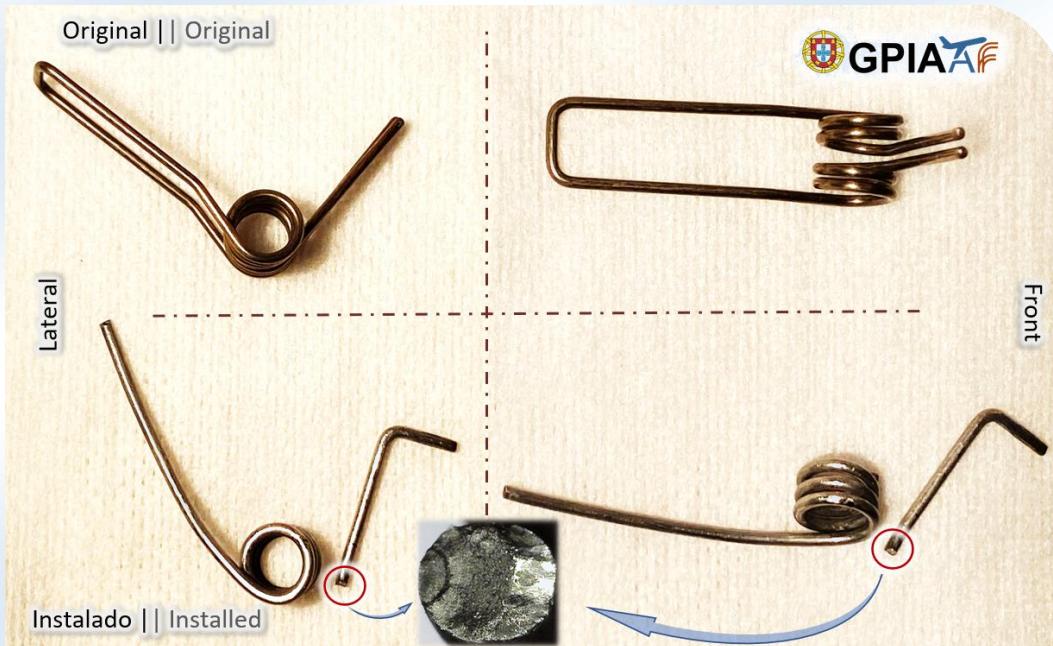
Figura 8 || Figure 8

The original spring (PN:05450/ARZ56141) has a double coil design which produces a continuous long double-arm and twin short-arm supports which press against the casing wall. The appearance and design of the installed spring, when compared with a new one (kindly supplied by Safran), highlights many differences. The investigation was not able to determine the origin of the spring installed.

The long arm allows it to have better contact with the back of the trigger and to supply the pressure required to keep it engaged with the swinging hook in its locked position.

Comparação entre a mola instalada e uma mola original
