AAIB Bulletin

4/2022

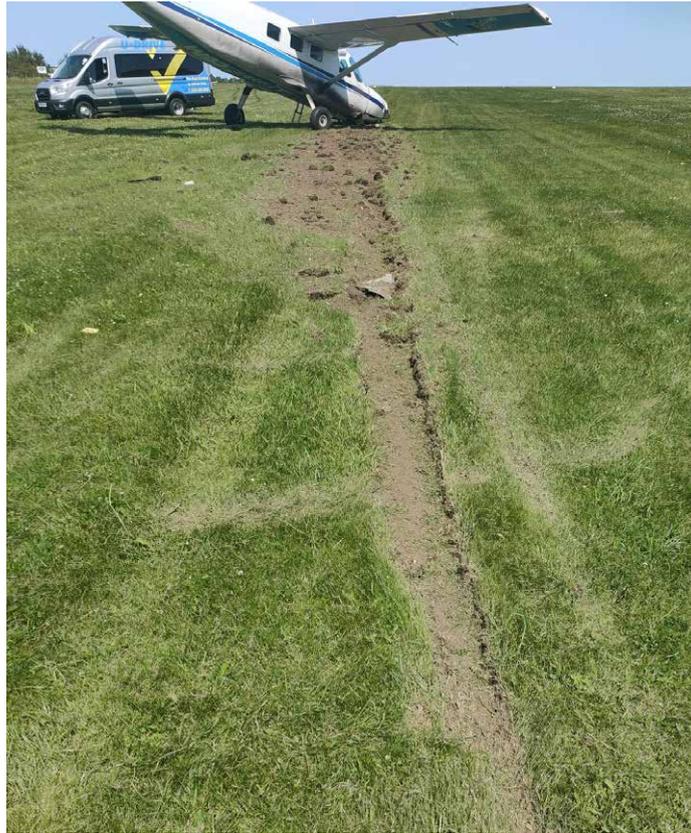
Figure 1

The aircraft was damaged beyond economical repair.

G-OJMP after the accident

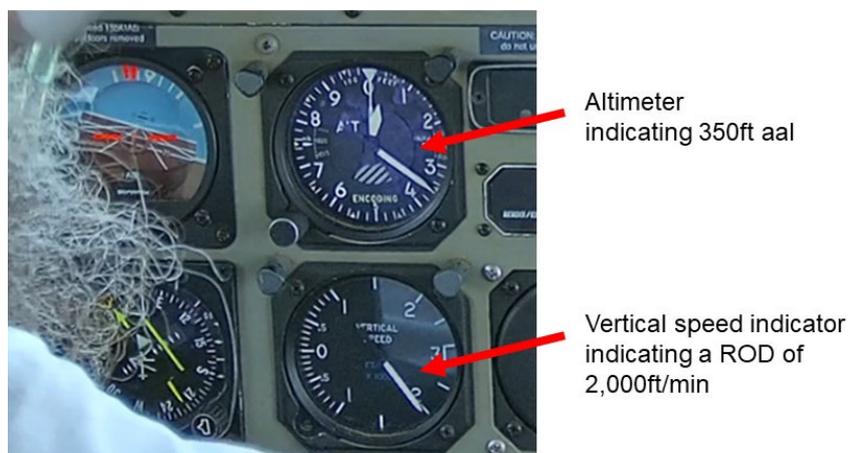
Figure 2

The final visible rate of descent was about 2,000 ft/min at 350 ft aal (Figure 2). This was just before the aircraft rolled out onto the final approach.

A still from the image recorder showing the ROD at 350 ft aal

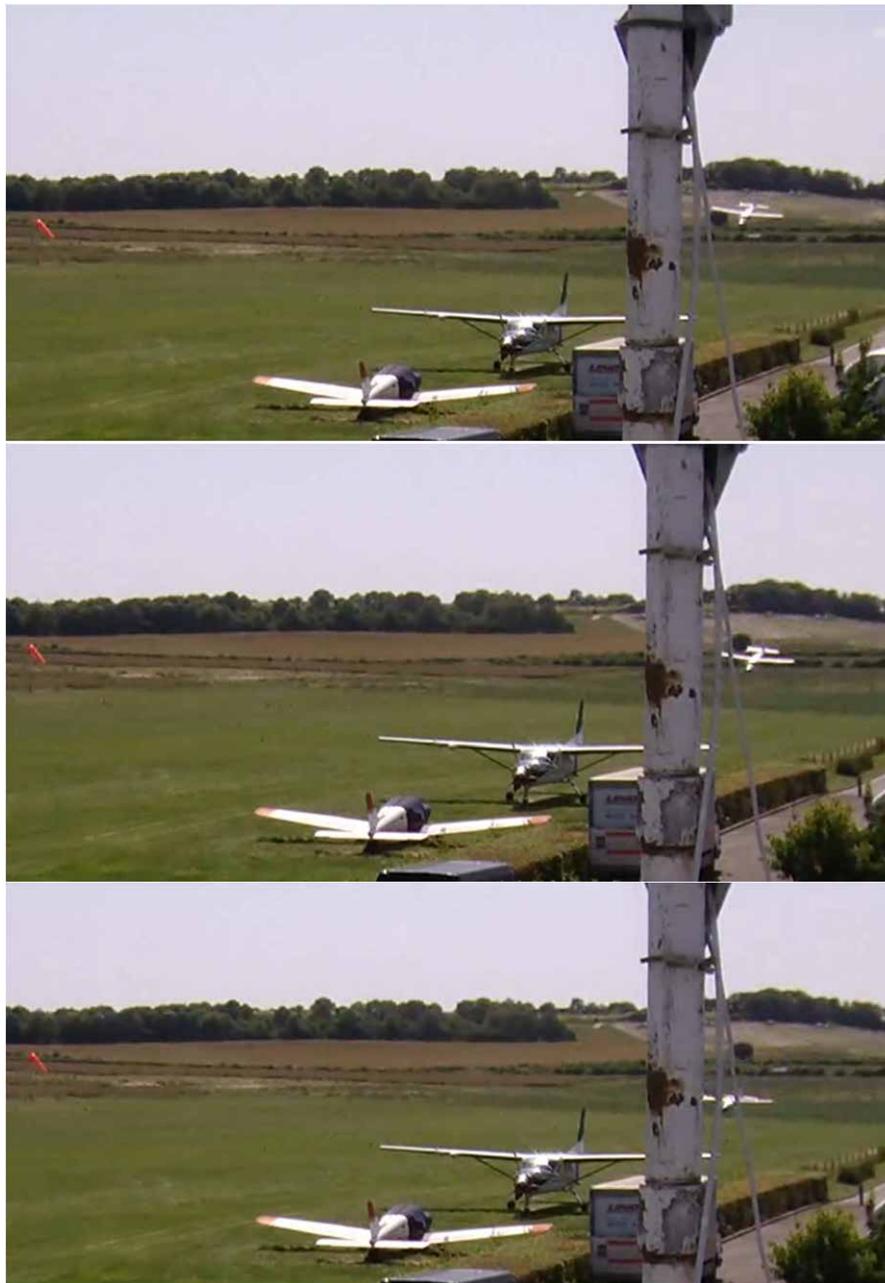
Figure 3

It could not be positively determined from the CCTV if the aircraft had its flaps down during the landing.

A series of stills from the CCTV showing the last moments of the approach

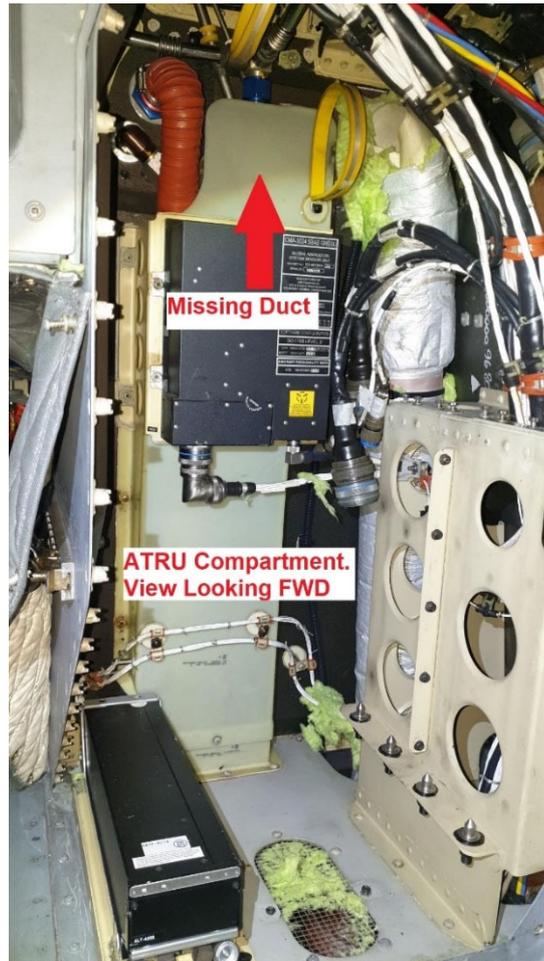
Figure 1

Subsequent inspection by the operator’s engineers showed that a heating duct in the right-hand rear area of the fuselage had collapsed and the external insulation was missing from a large section (Figure 1). The cockpit fans and two Auto-Transformer Rectifier Units (ATRU) which have integral cooling fans and are mounted close to the failed duct, were found to have ingested duct insulation material. The duct failure occurred at 1,399 flight hours since new.

Collapsed heating duct on G-MCGU

Following the duct failure on G-MCGU, the operator issued a Technical Directive requiring a one-time inspection of the heating duct on all its AW189s within 50 flight hours. It included visual inspection of the external surface of the duct, inspection of cabin floor heating outlets and (depending on aircraft configuration) the cockpit fan inlet, for evidence of insulation fibres which might indicate a possible duct breakdown. The inspection also included operation of the heating system to check for any anomalies or unusual odour.

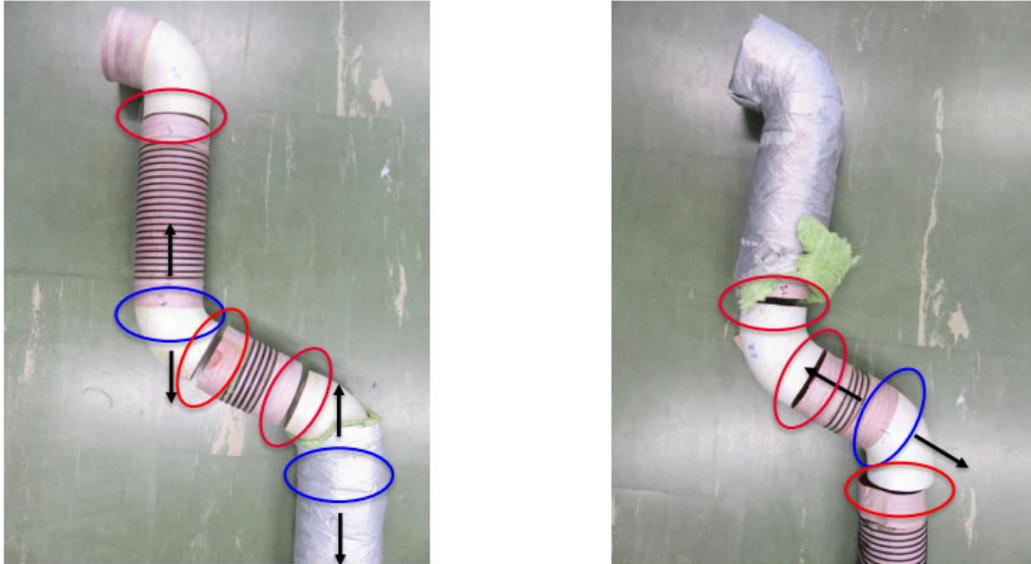
**Figure 3**

Failed heating ducts from G-MCGU (left) and G-MCGT (right)

On failed joints and those manually separated, adhesive was generally only present on the internal surfaces of the flexible sections. The only traces of adhesive present on the outer surfaces of the rigid bend sections appeared to be where adhesive had squeezed out from the joints during the assembly process.

The heating ducts on G-MCGU and G-MCGT failed due to non-uniform adhesion on the bonding surfaces between the rigid and flexible duct sections. This led to fragments of insulation material being discharged through the cabin in cockpit heating vents, causing respiratory irritation to the occupants and, in the case of G-MCGU, the presence of smoke which necessitated an emergency landing. The aircraft manufacturer published a Service Bulletin requiring inspection and modification of the duct as an interim solution, while it works with the duct manufacturer to achieve a permanent solution. A subsequent duct failure occurred on G-MCGV, which had the Service Bulletin embodied and this event will be reported separately by the AAIB.

Following examination in the aircraft manufacturer's laboratory, the failed ducts were sent to the duct manufacturer for further examination to determine if there were improvements to the duct design or manufacturing which could be implemented as a long-term solution. The results of that examination were not known at the time of writing this report, however as an interim solution, Leonardo Helicopters published Service Bulletin (SB) 189-296 'ATA 21 – Heating duct rear avionics bay inspection' on 23 July 2021.

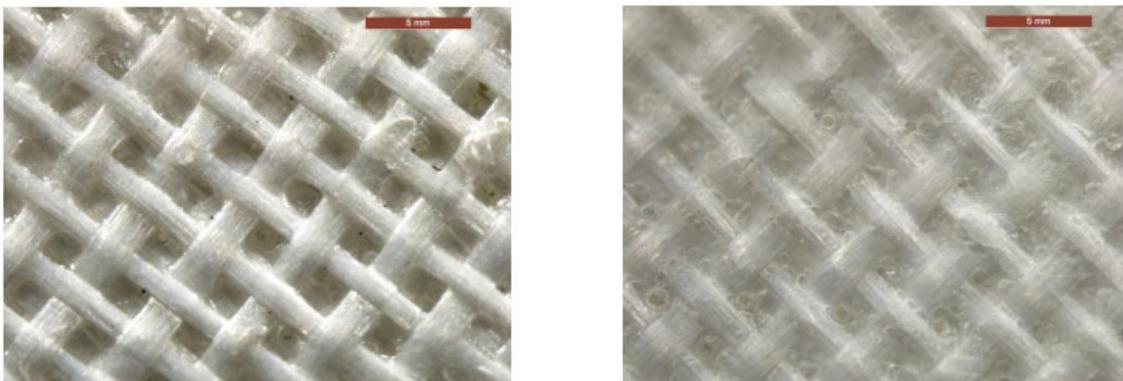
**Figure 4**

In this design, the rigid bends are fabricated from composite fibre bundles arranged in a criss-cross pattern, impregnated with resin. It was noted that the rigid sections did not exhibit uniform smoothness across their entire surface; in some areas, voids were evident between the fibre bundles, while in others, resin had filled the voids (Figure 4).

Surface of rigid bend sections, showing voids between fibre bundles

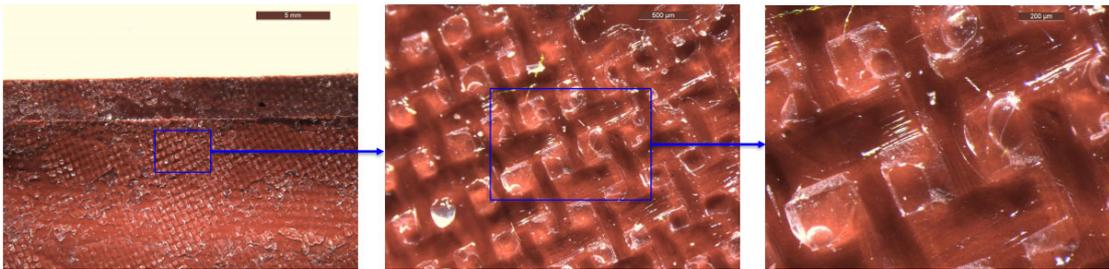
Figure 5

- Some areas exhibited cubic-shaped reliefs in the adhesive (Figure 5), caused by penetration of the adhesive into the voids between the crossed fibre bundles that make up the surface of the rigid bend sections.
- Some areas exhibited well-defined imprints of the crossed fibre bundles, while others exhibited only slight imprints (Figure 6).
- Some areas exhibited small and large bubbles in the adhesive (Figure 7).

Cubic-shaped reliefs in adhesive, corresponding to cross-fibre bundles on rigid sections of duct

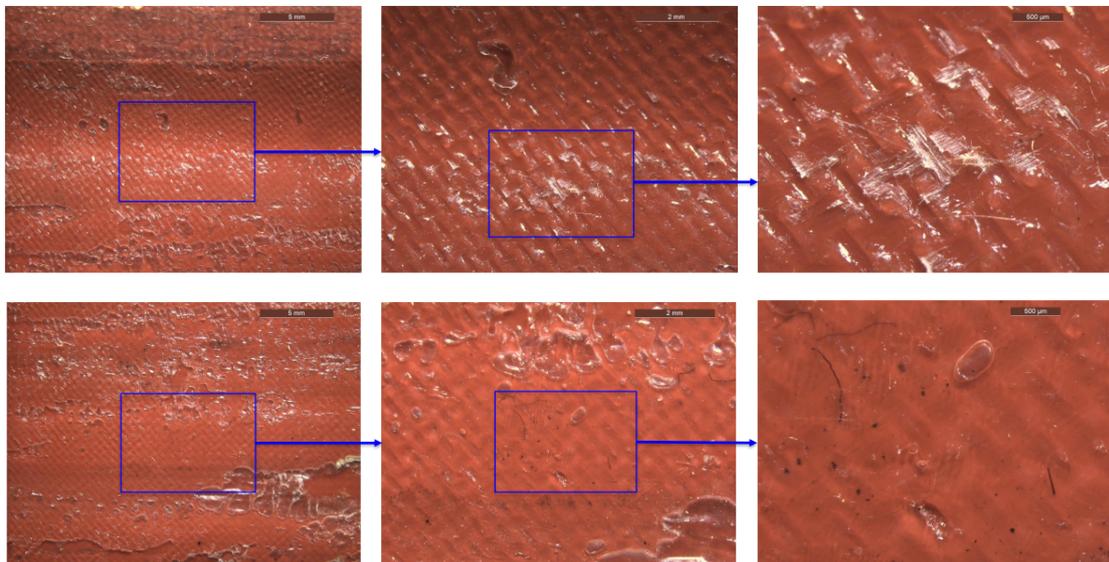
Figure 6

Areas of adhesive showing well-defined imprints from cross-fibre bundles (top row) and less well-defined imprints (bottom row)

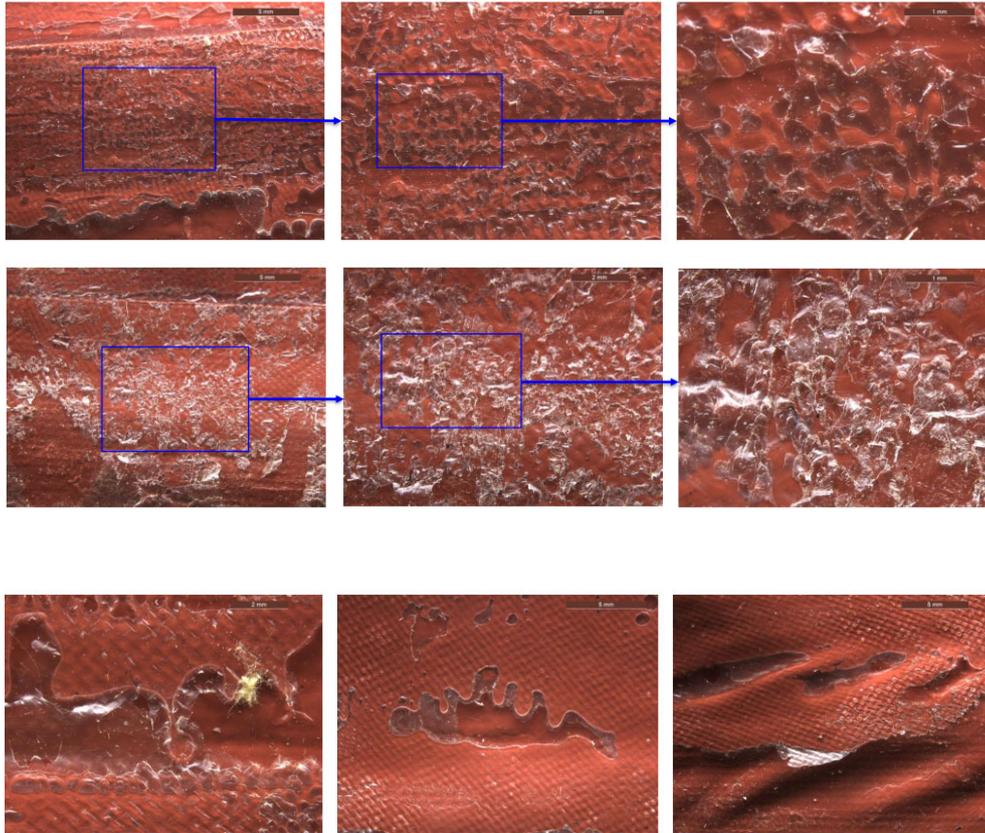
Figure 7

Areas of adhesive showing small intact bubbles (top row), small bubbles with broken film (middle row) and large bubbles (bottom row)

The manufacturer considered that the presence of bubbles in the adhesive may have been caused by relative movement between the mating surfaces during the bonding operation prior to solidification of the sealant, due to a loss of the applied mating pressure. The bubbles were characterised by weak films of adhesive, which would originally have been in contact with the surface of the rigid bend sections. When the joints separated, these films either remained intact or broke, forming some dimples in the latter case.

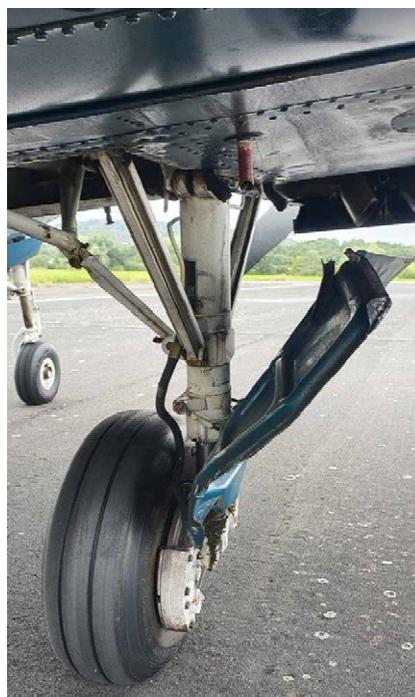
Figure 1

Both hinges on the right main landing gear door were found to be broken (Figure 1). There was no other damage to the aircraft.

Right main landing gear door retained by the two lower links

The pilot used the emergency landing gear manual extension system twice, which was contrary to the POH. The aircraft manufacturer said that the landing gear can over-travel if it is retracted using the manual system, thereby adversely loading the hinges. Both hinges were found to be broken after the aircraft landed and it is possible that retracting the gear manually could have caused or contributed to this.

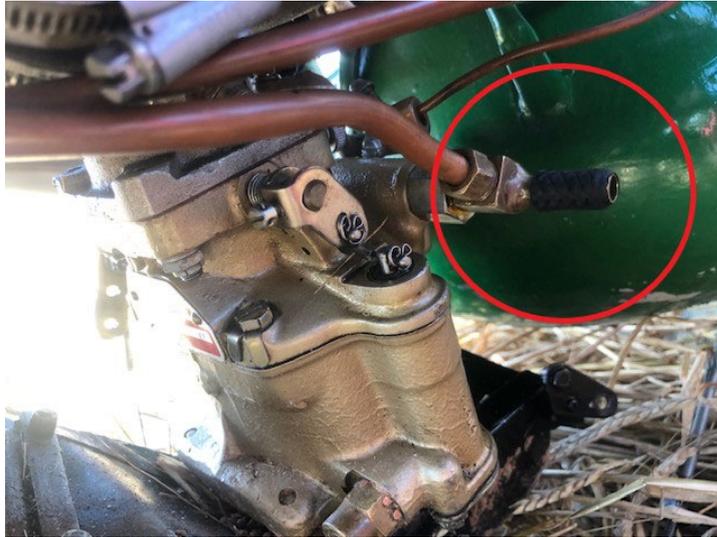
Figure 1

During the subsequent recovery of the aircraft, the pilot reported that when he removed the fuel delivery hose to the carburettor, the inner section of the fuel hose had remained attached to the carburettor's inlet union (Figure 1).

The inner section of the fuel hose that remained attached to the carburettor's inlet union (Image used with permission)

The AAIB inspected the fuel hose and noted that the hose had a 6 mm internal diameter compared to the inlet union's outer diameter of 7.75 mm. This potentially explains why, after the accident, a section of the fuel hose remained attached to the inlet union when the hose was removed. The hose appeared to be quite brittle with age and examination of the aircraft's maintenance records indicated that it had probably been installed on the aircraft for several years¹. It was also confirmed that the part, although designed for automotive use, was suitable for use with Avgas and Mogas, both of which G-AVLY routinely used.

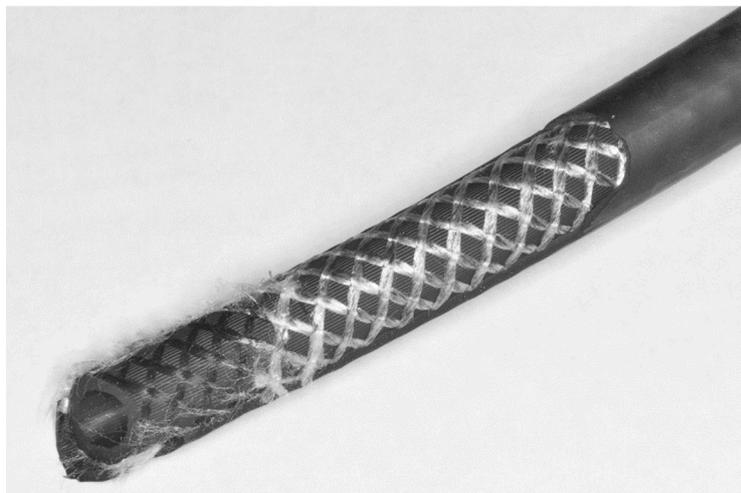
Figure 2

Sectioned fuel hose showing construction

The pilot reported that, as he detached the rest of the hose from the inlet union, he found that some of the fibre mesh material had bunched up against the face of the carburettor's fuel inlet, having potentially migrated through an internal split in the hose where it joined the inlet union. He considered that this may have caused a restriction in the engine's fuel flow and the subsequent loss of power. However, because the fuel hose was clamped to the inlet union, it would be difficult for a circumferential gap in the inner, fuel carrying section, to have opened wide enough to allow sufficient mesh material to migrate into the fuel flow.
