# FINAL REPORT

Aero AT-3R100, HA-NAD  
Tököl Airfield (LHTL), 26 August, 2023

Accident  
2023-1178-4

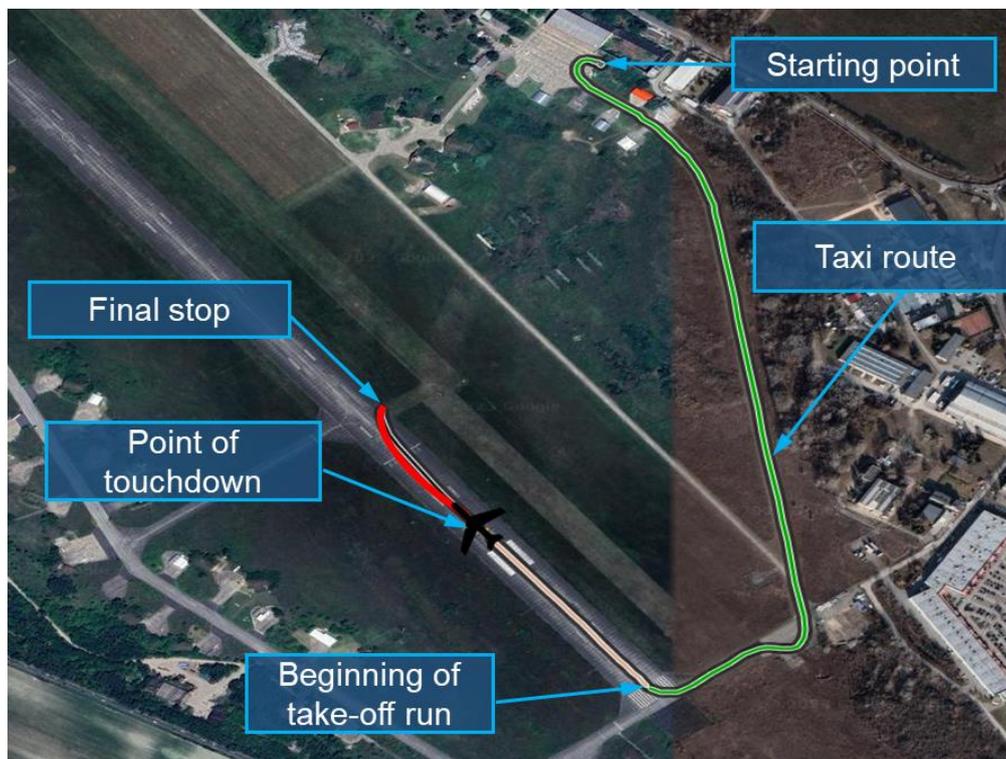
Following this, the pilot initiated the take-off with a flaps setting of 15 degrees at take-off power. Due to the tailwind and to avoid a stall, the pilot estimated a speed of approximately 55 knots to raise the aircraft's nose (rotation). According to the pilot, the aircraft was already airborne at 45 knots with the control stick in the neutral position. At a height of a few meters, the pilot intended to accelerate to the prescribed speed of 70 knots but encountered resistance in moving the control stick forward due to its reported jamming. At approximately 10 meters in altitude, the aircraft stalled and after the steep descent its nose struck the ground. After a ground collision sequence, it skidded approximately 75 meters, and the aircraft came to rest in a severely damaged condition at the geographical coordinates of N 47.34124, E 018.98612 at 4:44 PM.

Figure 2. The route of the aircraft (Source of the image: Airwin)
