# Quarterly Aviation Report

July - September 2023

Q3 2023

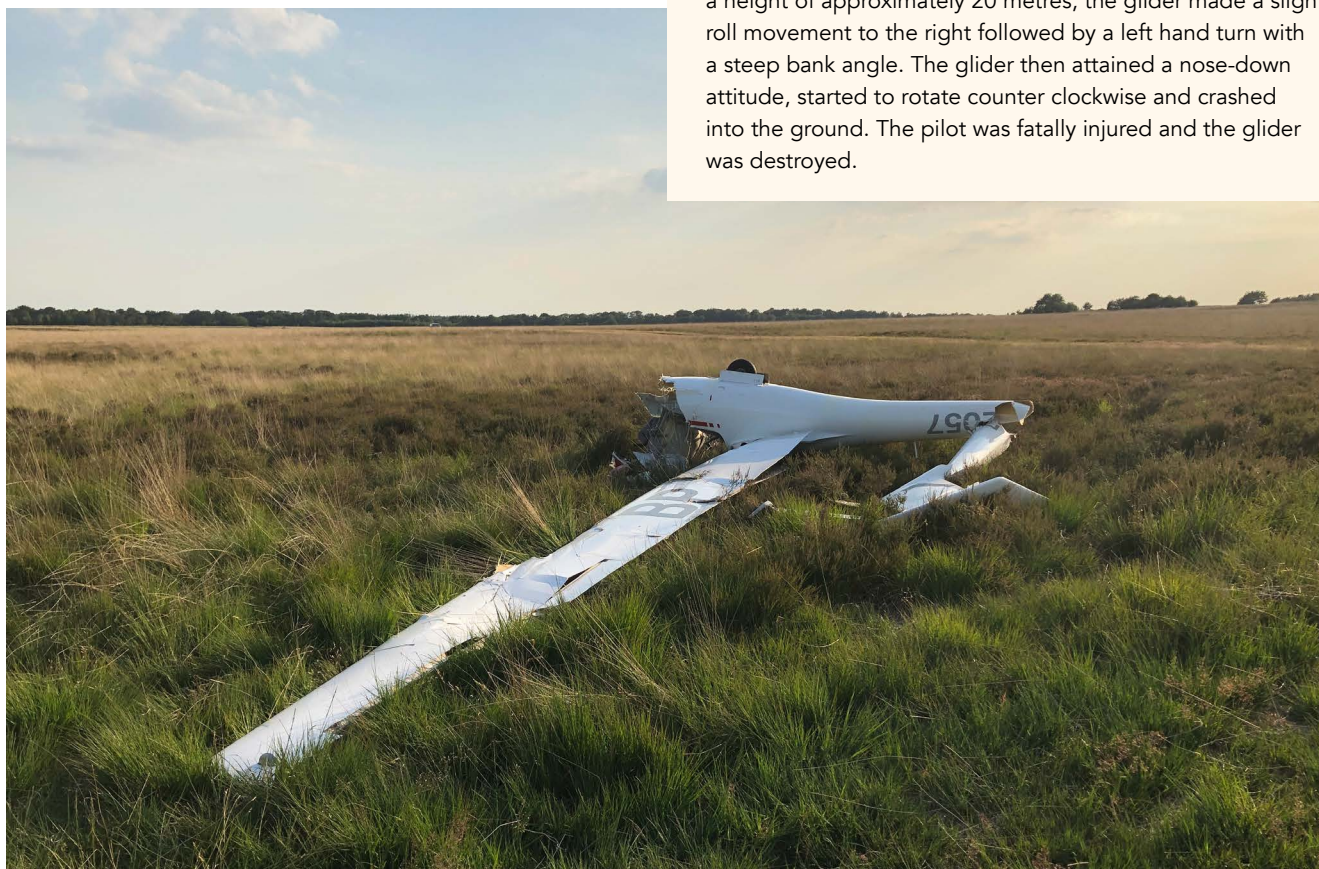
## ▼ Accident location.

## Crashed during winch launch, Rolladen-Schneider LS1-d, D-2057

Terlet glider airfield, 29 June 2022

The technical investigation of the wreckage has not revealed, insofar as this was still possible due to the damage of the glider, any technical defects in the flight controls that could have played a role in the accident. The slight roll movement of the glider to the right was the first indication of a stall.<sup>1</sup> The pilot's response to this resulted in the left hand nose down turn with a steep bank angle. That moment, the glider had entered a stall condition. The stall arose because the critical angle of attack had been exceeded, which was initiated by a high rotation rate in the beginning of the winch launch. The pilot was not able to recover from the stall at low height.

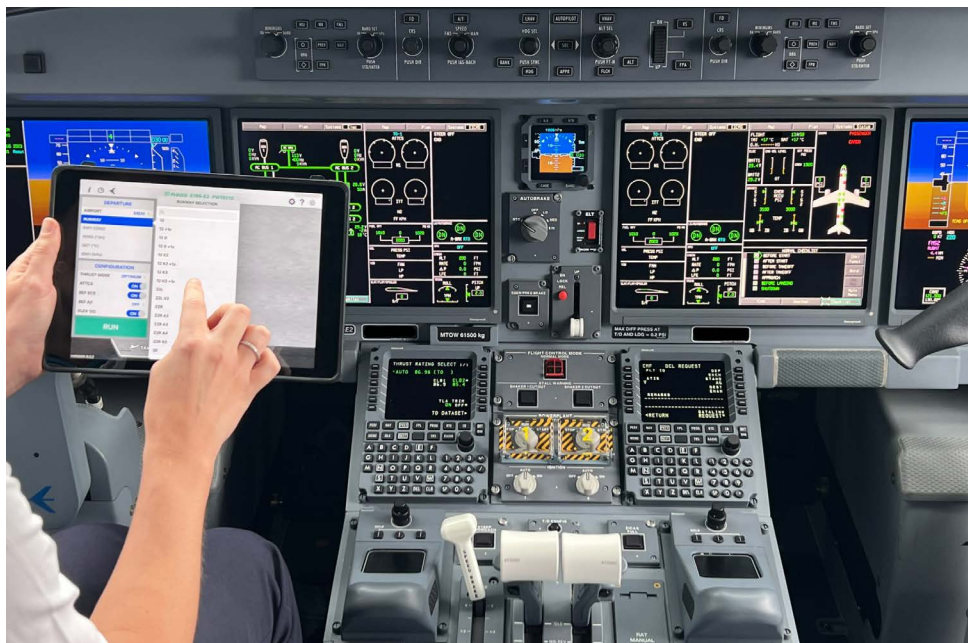
On 12 September 2021, a serious incident occurred with an Embraer 195-E2 at Berlin Brandenburg Airport (EDDB) in Germany. The aircraft took off with a selected amount of takeoff thrust, based on erroneous takeoff data. The Dutch Safety Board investigated the incident and found that the aircraft took off from intersection L5 - as the crew intended - while the performance calculation was based on intersection K5. The actual available runway length was 1,320 metres less than the runway length used in the calculation of the performance parameters. The selected thrust setting was such that the acceleration of the aircraft was too slow to safely take off from intersection L5. As a result, the aircraft became airborne 443 metres before the end of the runway. Safety margins were reduced during the takeoff. The aircraft would likely not have been able to safely abort the takeoff at speeds close to  $V_1$ .

▲ Cockpit Embraer 195 and iPad. (Source: airline)

The Board formulates three lessons and a recommendation. The lessons aim to improve learning by operators. Operators may focus on improving data availability by increasing the amount of data and increasing the diversity of data sources, while they should also prioritise difficult to identify hazards or low-frequency occurrences with potentially catastrophic consequences for investigations and mitigating actions. The recommendation aims to stimulate the development of onboard technical solutions to reduce the risk of using erroneous takeoff data.

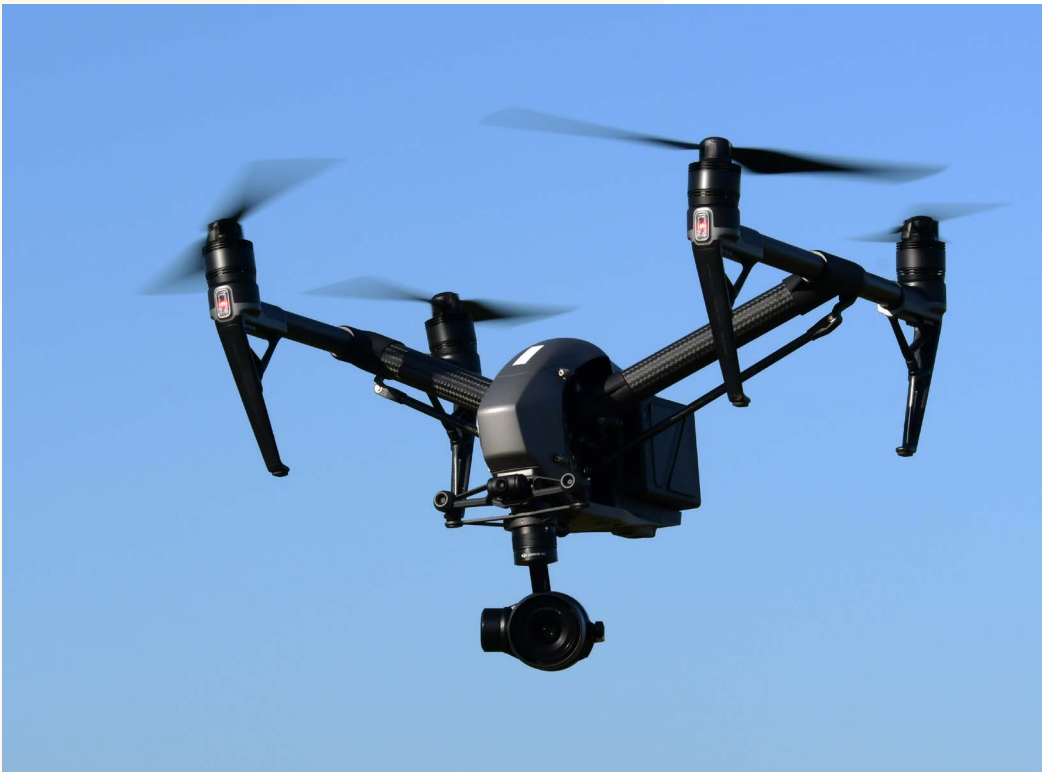
The Dutch Safety Board requested the manufacturer of the UAS to analyse the flight data. According to the manufacturer, the deviation between the compass and IMU yaw was likely the result of electromagnetic interference (EMI),<sup>7</sup> caused by the steel surrounding the bridge and the power lines present there.

▼ *Archieffoto DJI Matrice 210 V2.*

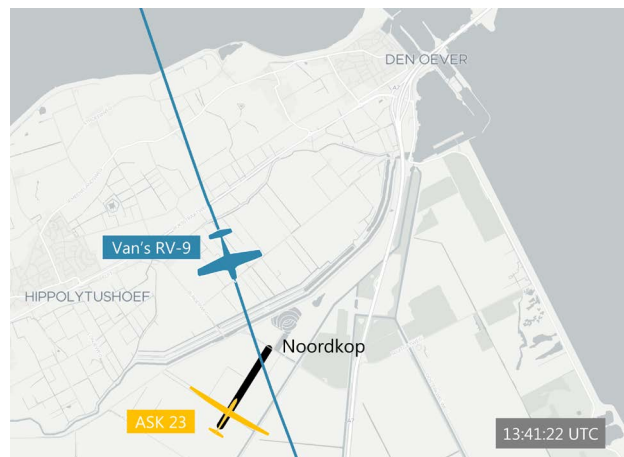
The FLARM<sup>11</sup> equipped ASK 23 B single-seat glider took off from Runway 03 at Noordkop glider airfield (hereafter Noordkop) for a local flight using the winch launch method. On board was a pilot who did not yet hold an Sailplane Pilot Licence and was making his 25th solo flight. Towards the end of the winch launch, the pilot observed a motorised aircraft at his 10 o'clock position flying towards a position above the winch path where the glider would soon afterwards be at almost the same altitude. The pilot pushed the stick forward and levelled the glider off after which he released the winch cable early. According to his estimate, the vertical distance between both aircraft at that moment was less than 50 metres. FLARM gave no warning.

The motorised aircraft was a single-engined Van's RV-9A. The aircraft had taken off from Texel International Airport (EHTX, hereafter Texel) for a VFR flight to Grimbergen Airfield (EBGB) in Belgium. The aircraft was flying from the south of the Wadden Sea Corridor towards the Pampus VOR<sup>12</sup> at an altitude of 1,275 feet. The pilot, who navigated using SkyDemon navigation software, was aware that he was in the vicinity of Noordkop. He tried to visually locate it, but did not see any airfield nor gliders (in the sky). Since, according to the pilot, there were no thermals above 1,200 feet, he had assumed that no gliding activities were taking place. The SafeSky application he used also gave no indication of any activity on the ground or in the air.

▲ The flight path of the RV-9A.
