RELATÓRIO SUMÁRIO DE ACIDENTE COM AERONAVE

AIRCRAFT ACCIDENT SUMMARY REPORT

Separação inadvertida e prematura do cabo da aeronave de reboque.

PROCESSO GPIAAF // GPIAAF PROCESS ID 2022/ACCID/05	<i>Classificação // Classification</i> Acidente // Accident
	<i>Tipo de evento // Type of event</i> GTOW Eventos relacionados com operações de reboque // Glider towing related events
OCORRÊNCIA // OCCURRENCE	
<i>Data // Date</i> 11-11-2022	<i>Hora // Time</i> 12:40 UTC
<i>Local // Location</i> Sudoeste do aeródromo num campo aberto junto à estrada N114 South-West of the aerodrome in an open field close to N114 road	
AERONAVE // AIRCRAFT	
<i>Tipo // Type</i> PZL-Swidnik PW-6U	<i>N.º de série // Serial No.</i> 78.02.08
<i>Categoría // Category</i> Planador // Glider	
VOO // FLIGHT	
<i>Origem // Origin</i> Aeródromo da Amendoeira (LPMN)	<i>Destino // Destination</i> Aeródromo da Amendoeira (LPMN)
<i>Tipo de voo // Type of flight</i> Aviação Geral // General Aviation	<i>Tripulação // Crew</i> 02
<i>Fase do voo // Phase of flight</i> Descolagem // Take-off	<i>Passageiros // Passengers</i> 00

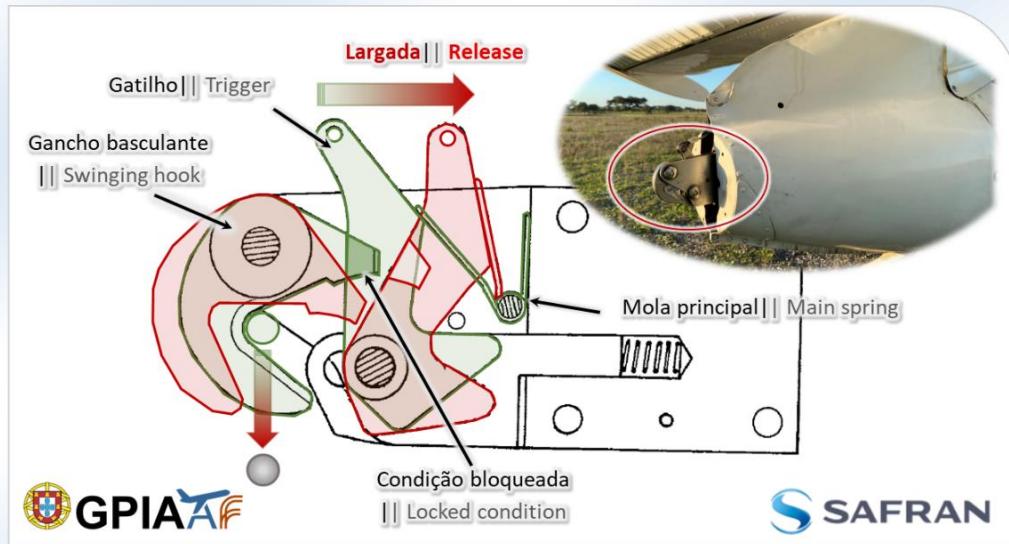
Figura 4 || Figure 4

A aeronave de reboque, estava equipada com o sistema de gancho de reboque Aerazur AIR 12A no cone de cauda (ver Figura 4).

The towing aircraft was fitted with an Aerazur AIR 12A towing hook in its tail cone (see Figure 4).

With the swinging hook unlocked, the connecting ring is free to drop, under its own weight and that of the entire towing rope, consequently interrupting the tow and releasing the glider.

The purpose of the main spring is to apply sufficient pressure onto the trigger arm such as to maintain the locked position and prevent inadvertent release when this is not commanded by the pilot.

Gancho de reboque Aerazur – Sistema normal de largada

There was evidence of material deformation in the contact area of the swinging hook due to wear by the towing ring. Similar wear deformation was also evident along the lip of the plunger and elsewhere in the hook mechanism which caused play in the moving parts.

Upon disassembly, it was found that the spring had been installed on the stop of the trigger instead of being further back in the correct position, on the spring support.

Quanto à mola em si, constatou-se que estava danificada (fissuras), tendo o braço curto partido com um pequeno contacto.

At some undetermined point, the casing had been disassembled and the spring reinstalled incorrectly. No record of this maintenance action could be found.

As for the spring itself, it was found to be in a very fragile (cracked) condition and the short arm separated with very little effort.

Flight safety is compromised when the hook does not operate as per design due to inadequate maintenance, which in turn creates an unairworthy aircraft condition. Considering the dated design and certification standards of the component, the airworthiness of a sound Aerazur hook could also come into question were it to be subjected to the current airworthiness requirements for tow releases laid down in ETSO-2C513, which came into force in 2008.
