AAIB Bulletin

4/2022

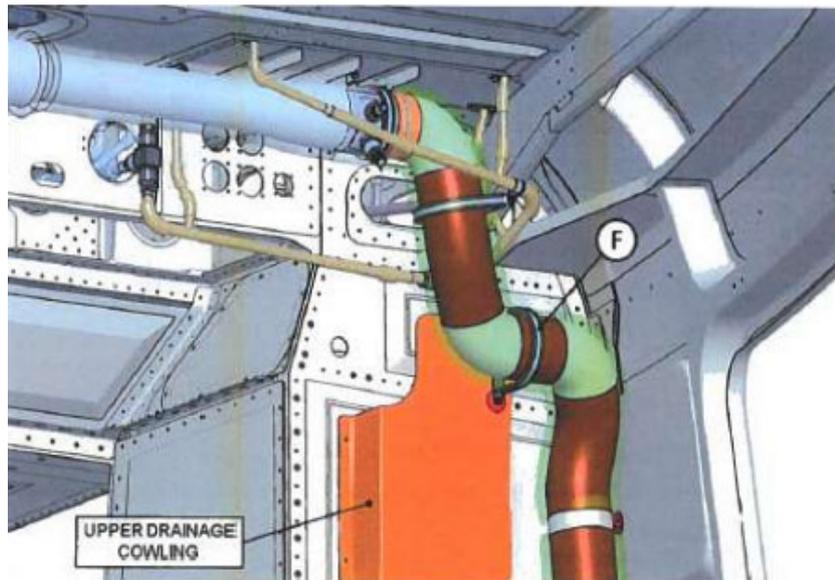
Figure 2

The AW189 heating system mixes bleed-air from the engines, or the Auxiliary Power Unit (APU), with external ambient air. The heating duct takes the hot air from the engine deck down through the baggage compartment in the right rear fuselage and under the floor, where it is routed forward to supply the cockpit and cabin heating vents. The section of duct that failed runs close to the avionics rack. To accommodate a change in direction in the duct routing, this part of the duct is comprised of alternating flexible and rigid bend sections, bonded together using F6065, a two-part silicon pressure-sensitive adhesive (Figure 2).

Heating duct on AW189 showing flexible sections in brown and rigid sections in green (Circle 'F' indicates a securing 'P-clamp')

The SB requires operators to perform a one-off inspection of the heating duct and to improve installation of the duct by repositioning an existing 'P-clamp' at one of the bonded joints (shown as item F in Figure 2) and introducing an additional fixing at another joint. The compliance instructions require that the SB is embodied within 400 flight hours or 12 months from date of publication, whichever occurs first.
